TECHNICAL APPENDIX 3.3: TURNING AREAS SAFETY AUDIT

Kirkton Energy Park
Prepared for: Kirkton Wind Farm Ltd

STAGE 1-2 ROAD SAFETY AUDIT

Kirkton Wind Farm

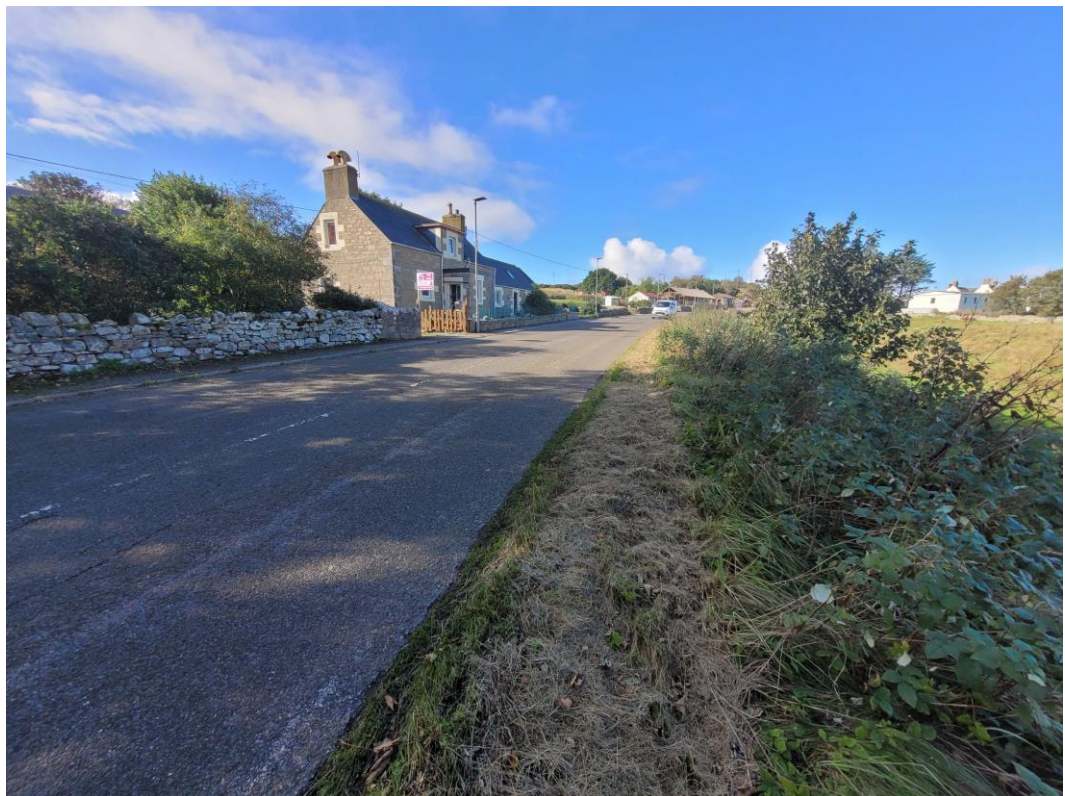
Location A: Melvich Village site access.

Summary: Restricted visibility from the access may lead to collisions with approaching traffic.

No visibility splays have been provided for this site, and while sight lines are generally good, a tree on the western side of the proposed access may inhibit visibility in this direction, particularly for site staff in normal vehicles leaving the site, resulting in collisions with eastbound traffic.

It is recommended that the visibility splays are cleared of obstructions.

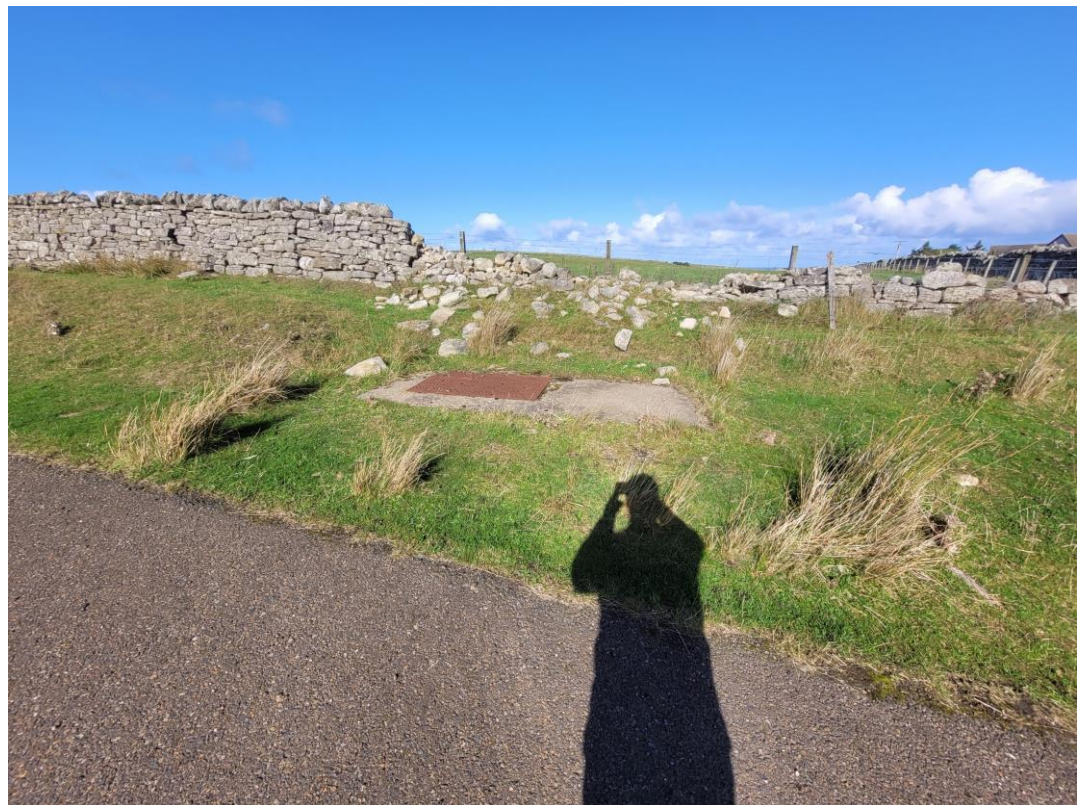
Location B: Strathy site access.

Summary: Existing chamber in access may become a slip hazard or may collapse.

The proposed access point coincides with an existing chamber with a metal cover. This is on a slope and may become slippery with use causing site traffic to lose control. Further, the overrunning of the chamber by heavy traffic may cause it to collapse risking injury to operatives.

It is recommended the chamber and cover are relocated, or reinforced, with a skid resistant cover.

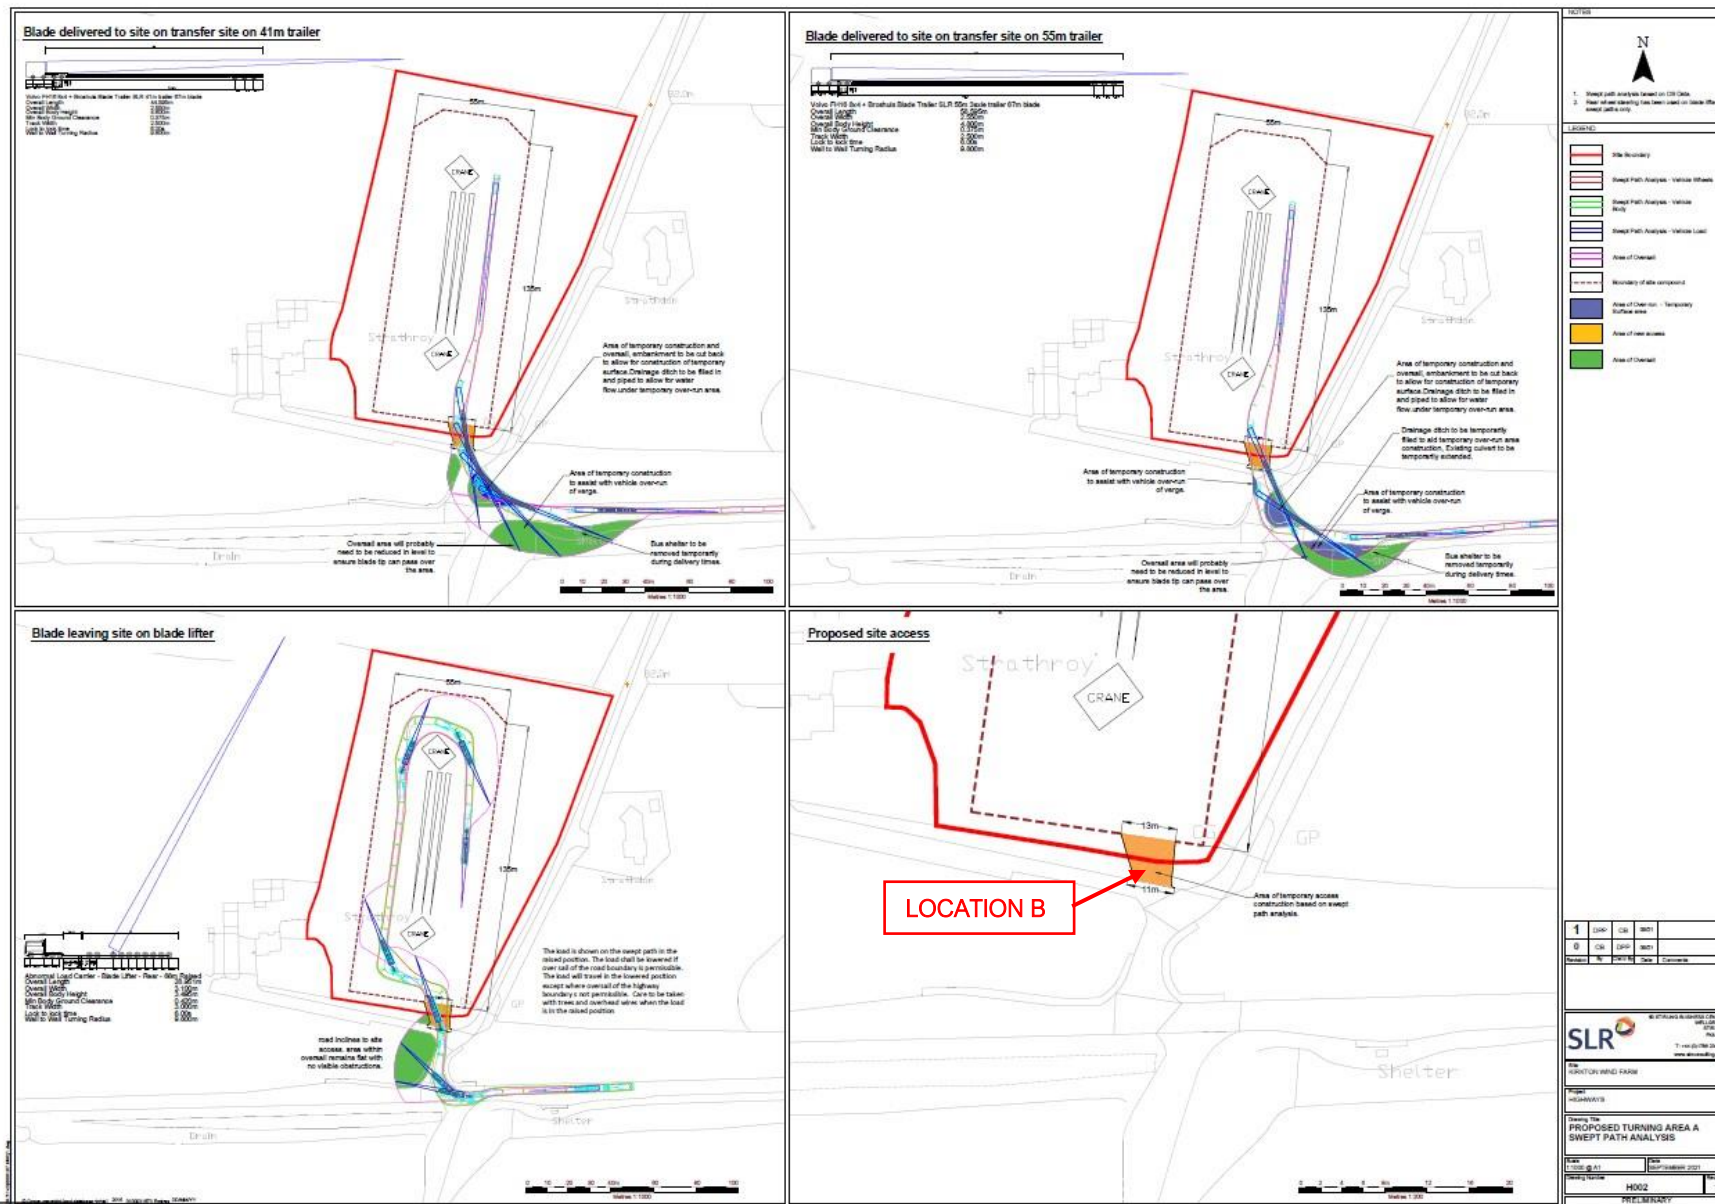
Appendix C

- 1.11 A submitted design drawing has been annotated to show the locations of any problems identified during this Stage 1-2 Road Safety Audit. This plan can be found at **Appendix C**.
