TECHNICAL APPENDIX 10.4: SCHEDULE OF WATERCOURSE CROSSINGS

Kirkton Energy Park

Prepared for: Kirkton Wind Farm Ltd

SLR Ref: 428.11143.00001
Version No: 1
November 2022

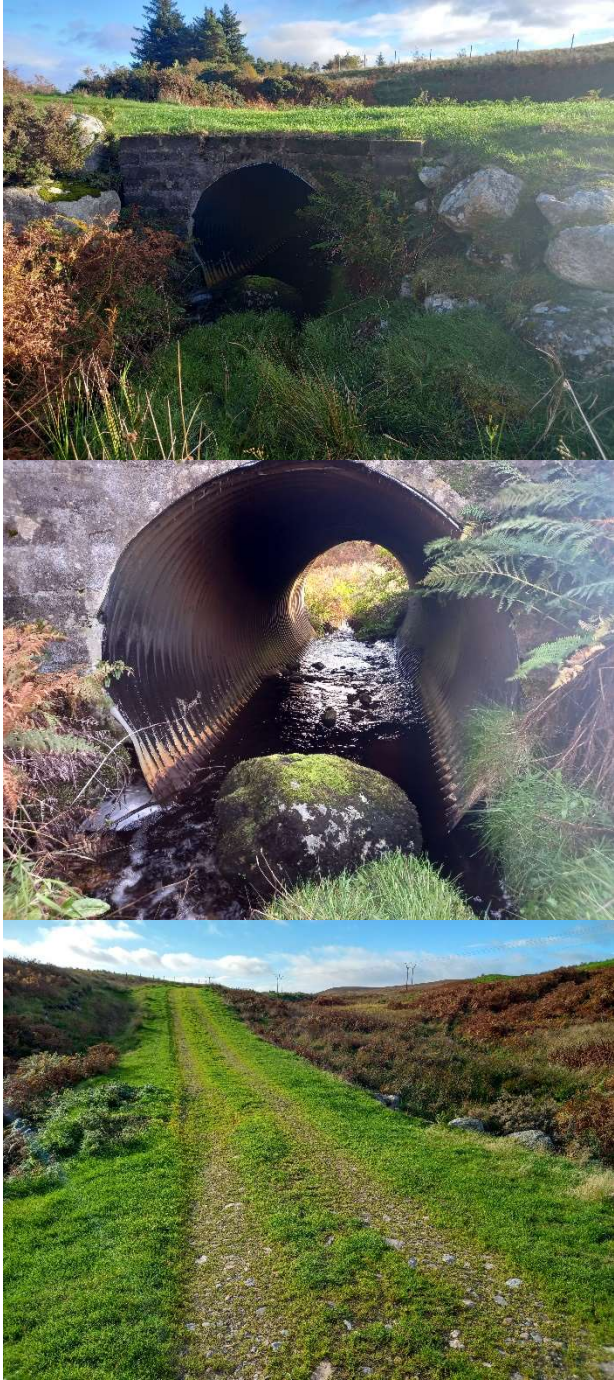
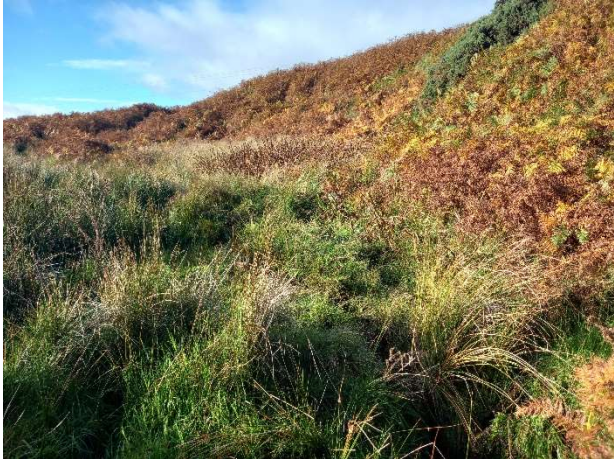
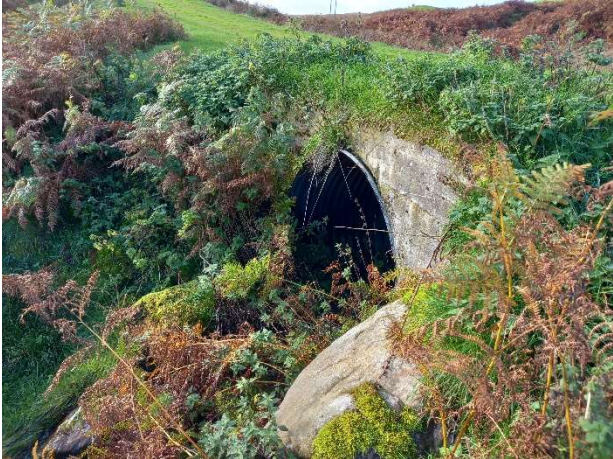
No.	Watercourse Crossing Details	Photograph of Existing/New Watercourse Crossing Point	Photograph Looking Upstream of Watercourse Crossing	Photograph Looking Downstream of Watercourse Crossing
3	<p>Watercourse Crossing: WX03</p> <p>Status: Existing</p> <p>NGR: 288662 961252</p> <p>Location: Site entrance road, north west of the proposed substation compound location.</p> <p>Watercourse width: - variable and braided upstream, 0.4m wide channels within 5-10m wide 'valley'</p> <p>Watercourse depth: 0.15m deep channels set within 2m deep 'valley'</p> <p>Notes: Corrugated iron, circular, 1.5m diameter culvert</p> <p>Brick and concrete headwall construction</p>

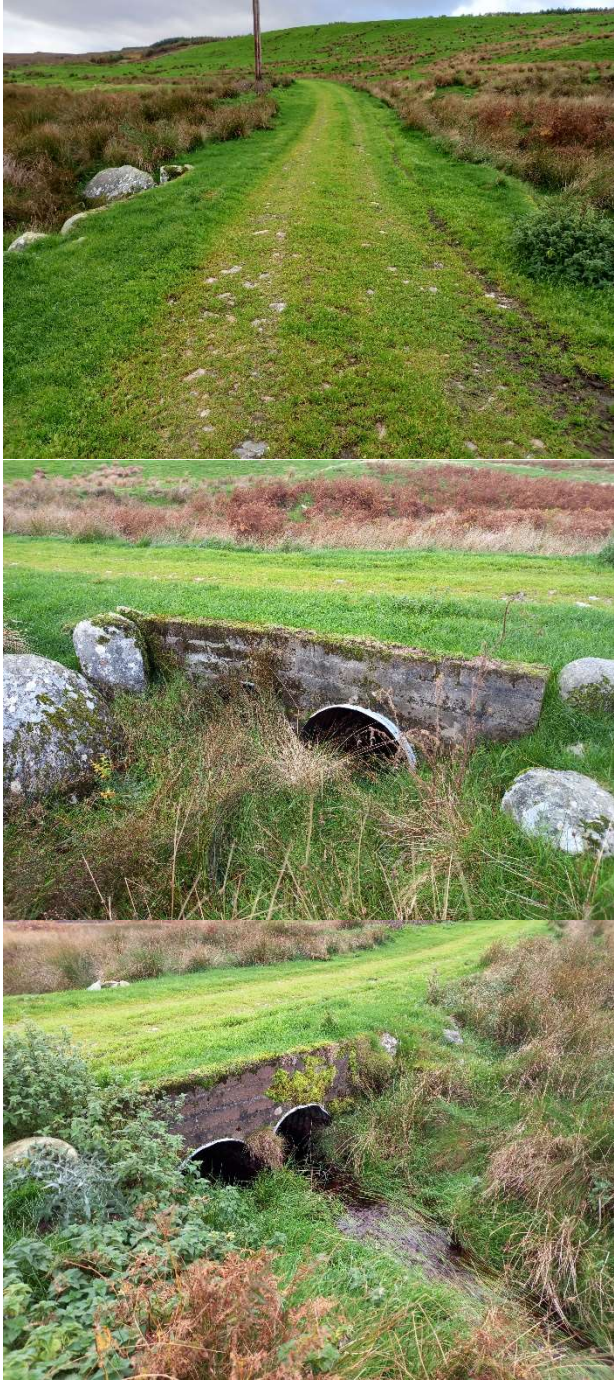
No.	Watercourse Crossing Details	Photograph of Existing/New Watercourse Crossing Point	Photograph Looking Upstream of Watercourse Crossing	Photograph Looking Downstream of Watercourse Crossing
4	<p>Watercourse Crossing: WX04</p> <p>Status: Existing</p> <p>NGR: 288603 961123</p> <p>Location: North east of the proposed construction compound, and west of the proposed substation compound location.</p> <p>Watercourse width: poorly defined overgrown 0.6m wide channel</p> <p>Watercourse depth: 0.15m deep channel with soft sediment bed</p> <p>Notes: Existing twin corrugated iron 1m diameter culvert. Brick and mortar headwall construction</p>

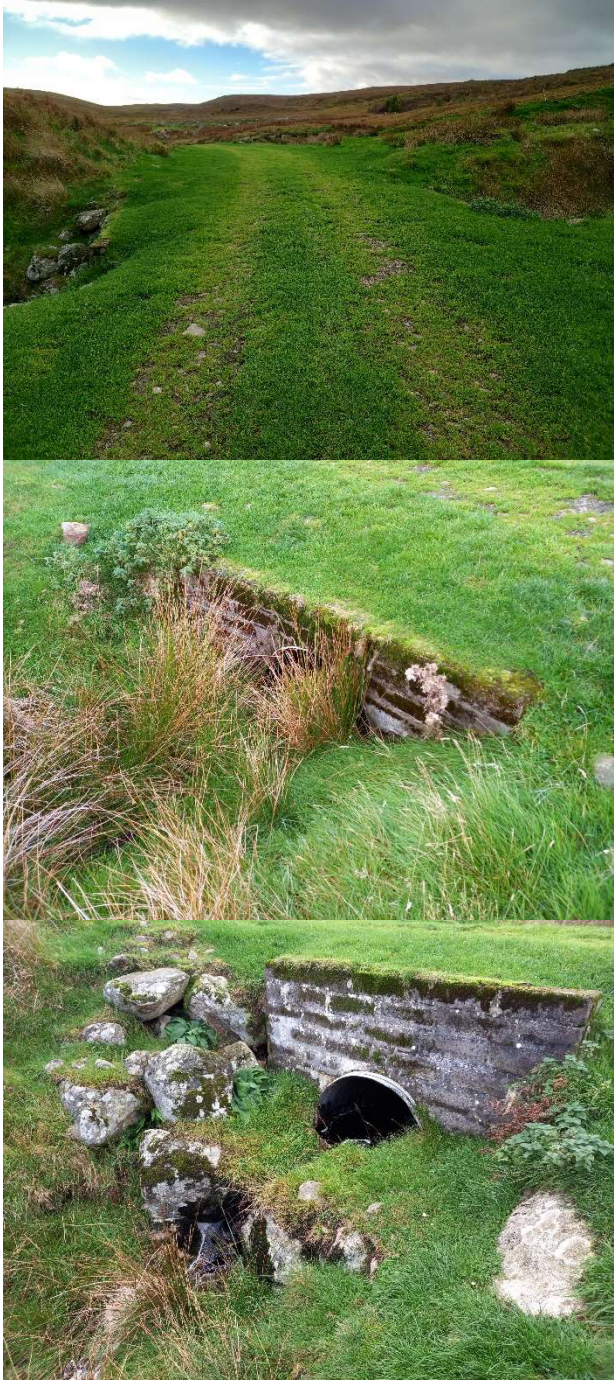
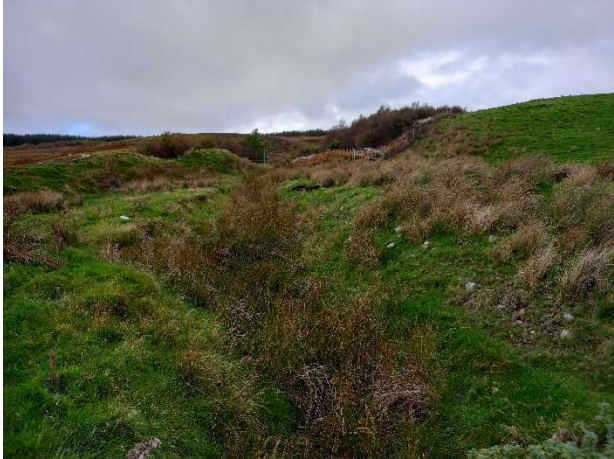
No.	Watercourse Crossing Details	Photograph of Existing/New Watercourse Crossing Point	Photograph Looking Upstream of Watercourse Crossing	Photograph Looking Downstream of Watercourse Crossing
5	<p>Watercourse Crossing: WX05</p> <p>Status: Existing</p> <p>NGR: 288466 960965</p> <p>Location: South of the proposed construction compound.</p> <p>Watercourse width: 0.4m</p> <p>Watercourse depth: 0.2m</p> <p>Notes: Existing corrugated iron 1m diameter culvert. Brick and mortar headwall construction</p>

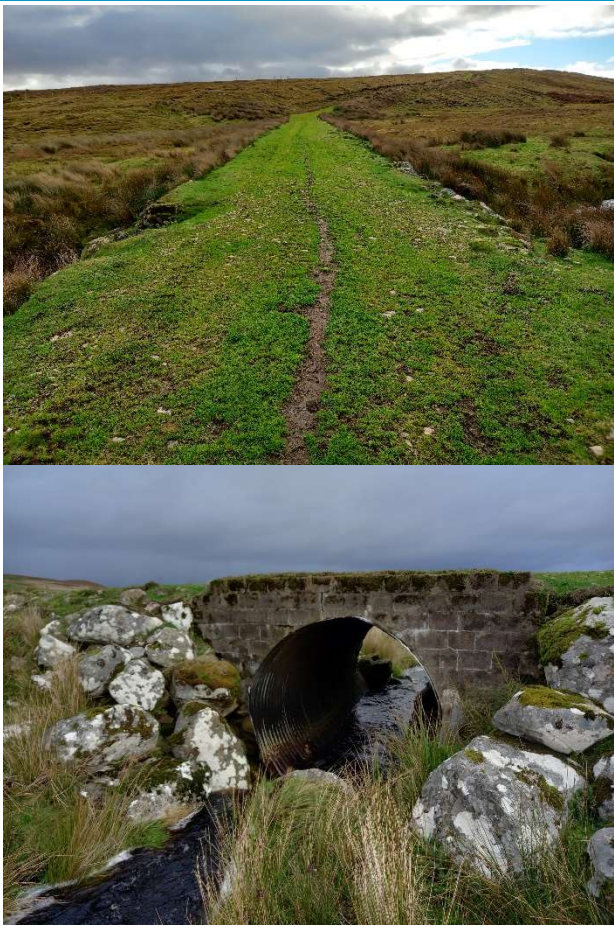
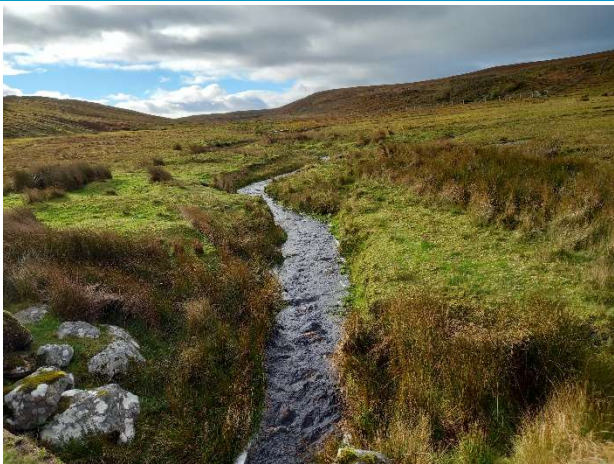
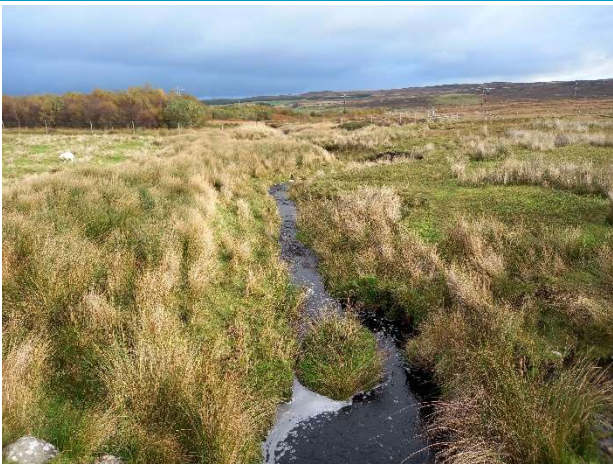
No.	Watercourse Crossing Details	Photograph of Existing/New Watercourse Crossing Point	Photograph Looking Upstream of Watercourse Crossing	Photograph Looking Downstream of Watercourse Crossing
9	<p>Watercourse Crossing: WX09</p> <p>Status: Existing</p> <p>NGR: 288485 960718</p> <p>Location: South of WX07 and on the track to turbines 5 to 11.</p> <p>Watercourse width: 0.8m</p> <p>Watercourse depth: 0.3m deep channel with 0.4m banks</p> <p>Notes: 1.8m diameter corrugated iron circular culvert.</p> <p>Some scour upstream and downstream in structure</p>

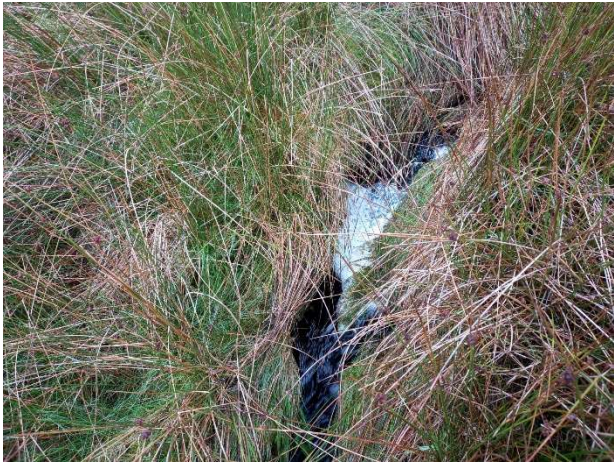
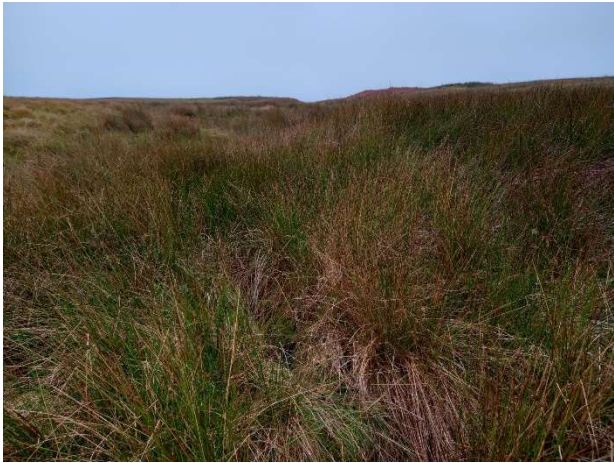
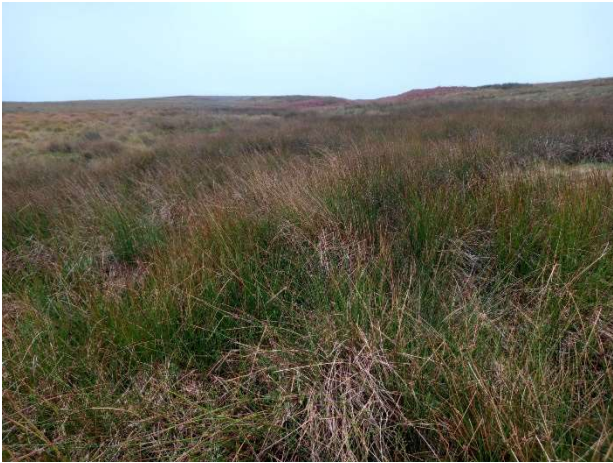
10	<p>Watercourse Crossing: WX10</p> <p>Status: New</p> <p>NGR: 287891 958992</p> <p>Location: On the proposed new track between turbines 7 and 8.</p> <p>Watercourse width: 0.4m</p> <p>Watercourse depth: 0.15m</p> <p>Notes: 0.5m deep banks set within sinuous valley with rushes bound to the watercourse. 1m/s flow at time of site survey.</p>
