# TECHNICAL APPENDIX 13.6: ETSU-R-97 ASSESSMENT GRAPHS

**Kirkton Energy Park**  
Prepared for: Kirkton Wind Farm Ltd

SLR Ref: 428.11143.00001  
Version V1  
November 2022

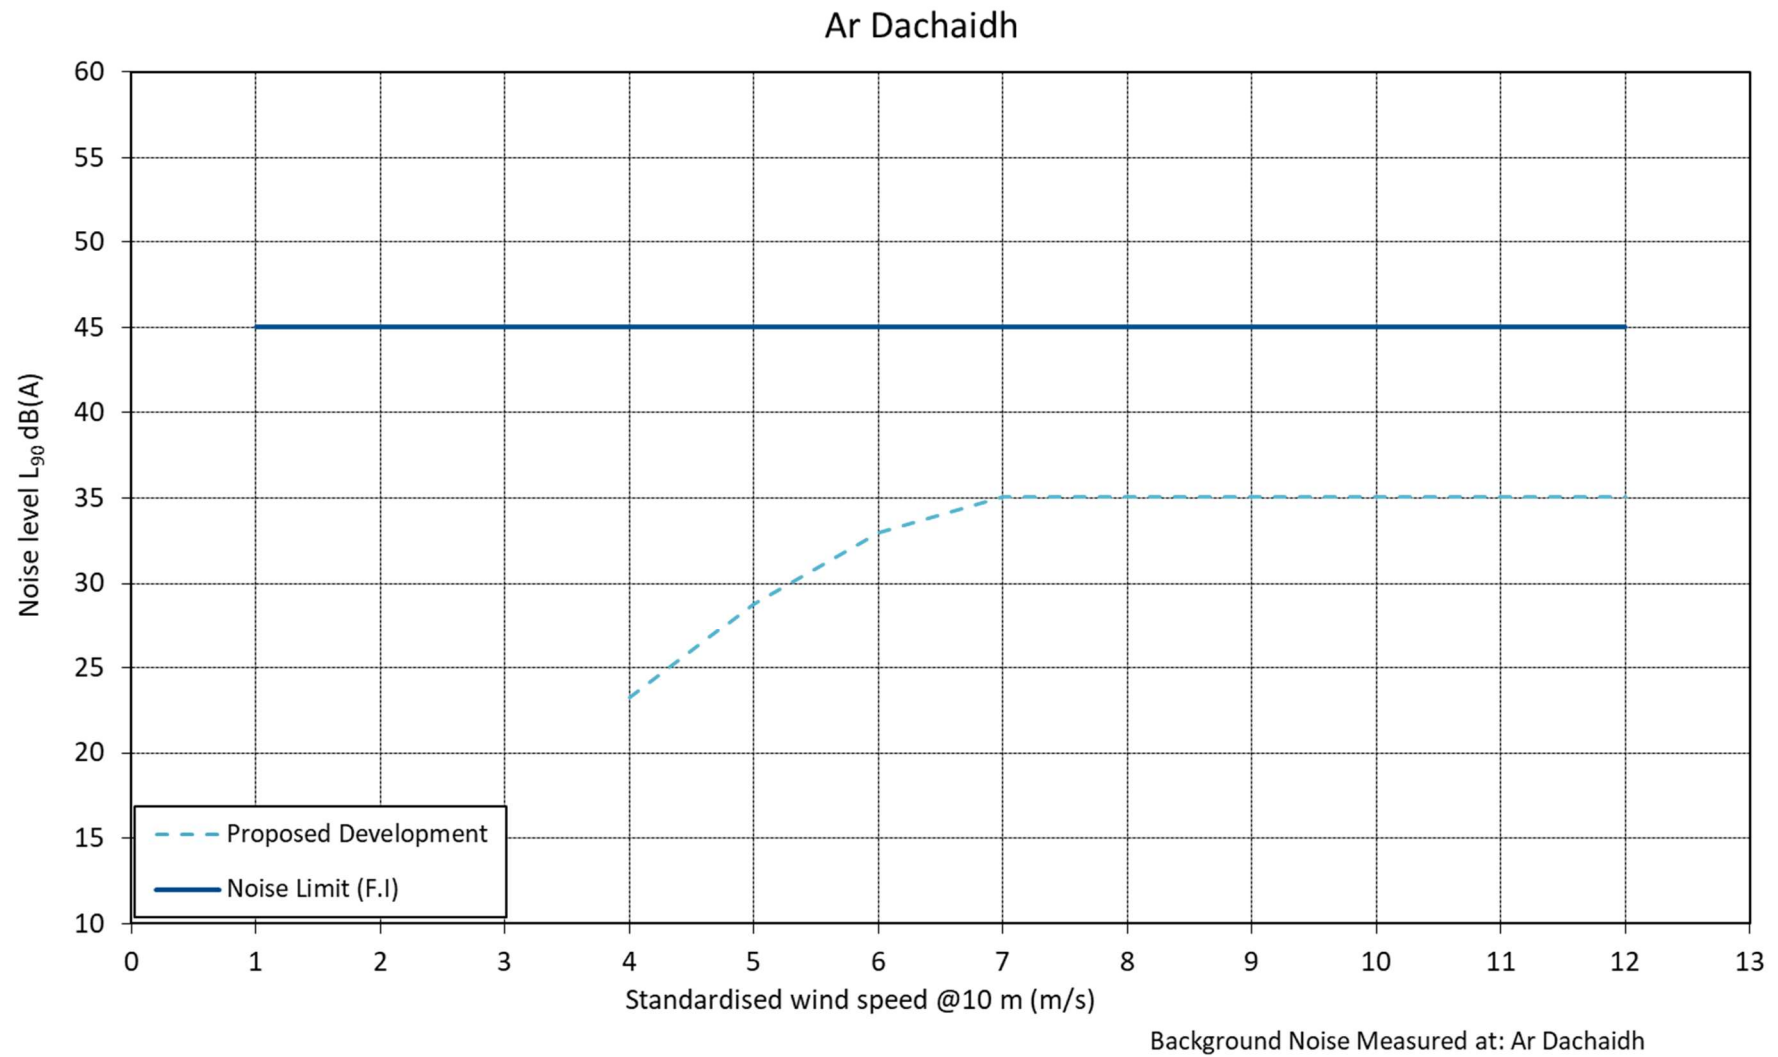
Graph 13-13: ETSU-R-97 Assessment Graph – NSR01 Ar Dachaidh

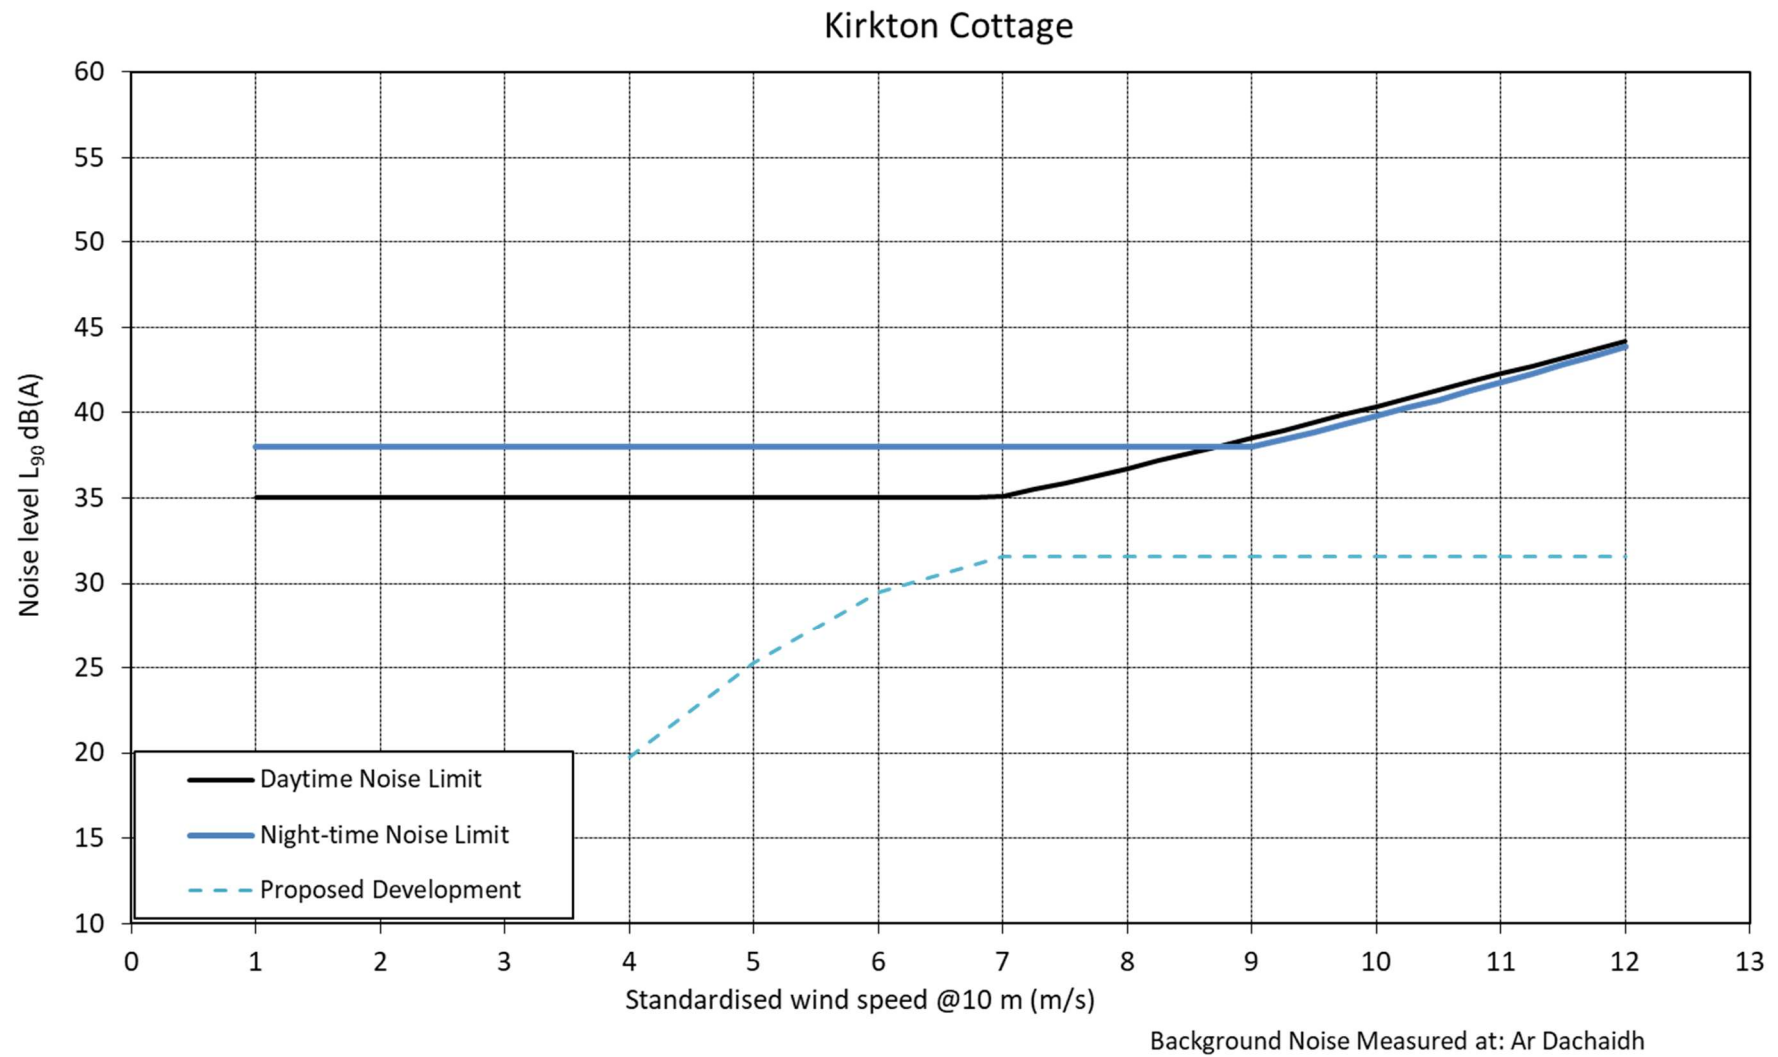
Graph 13-14: ETSU-R-97 Assessment Graph – NSR02 Kirkton Cottage

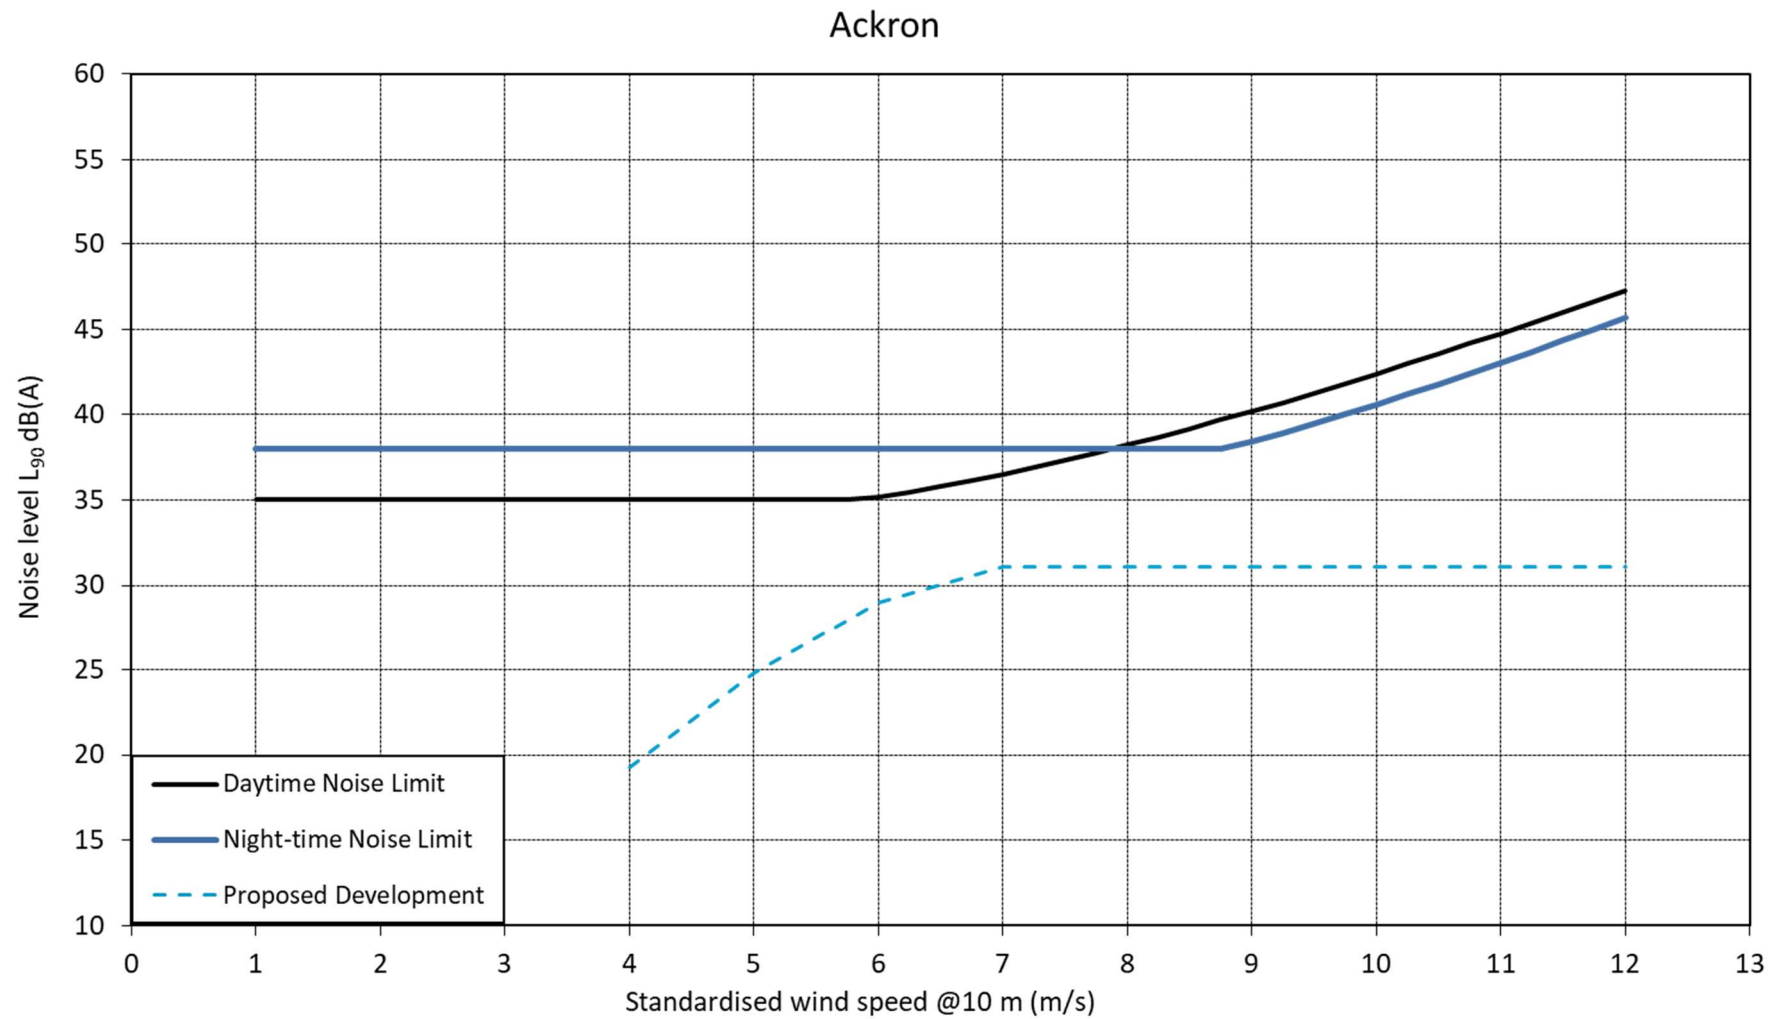
Graph 13-15: ETSU-R-97 Assessment Graph – NSR03 Ackron

Background Noise Measured at: Tigh Na Breac

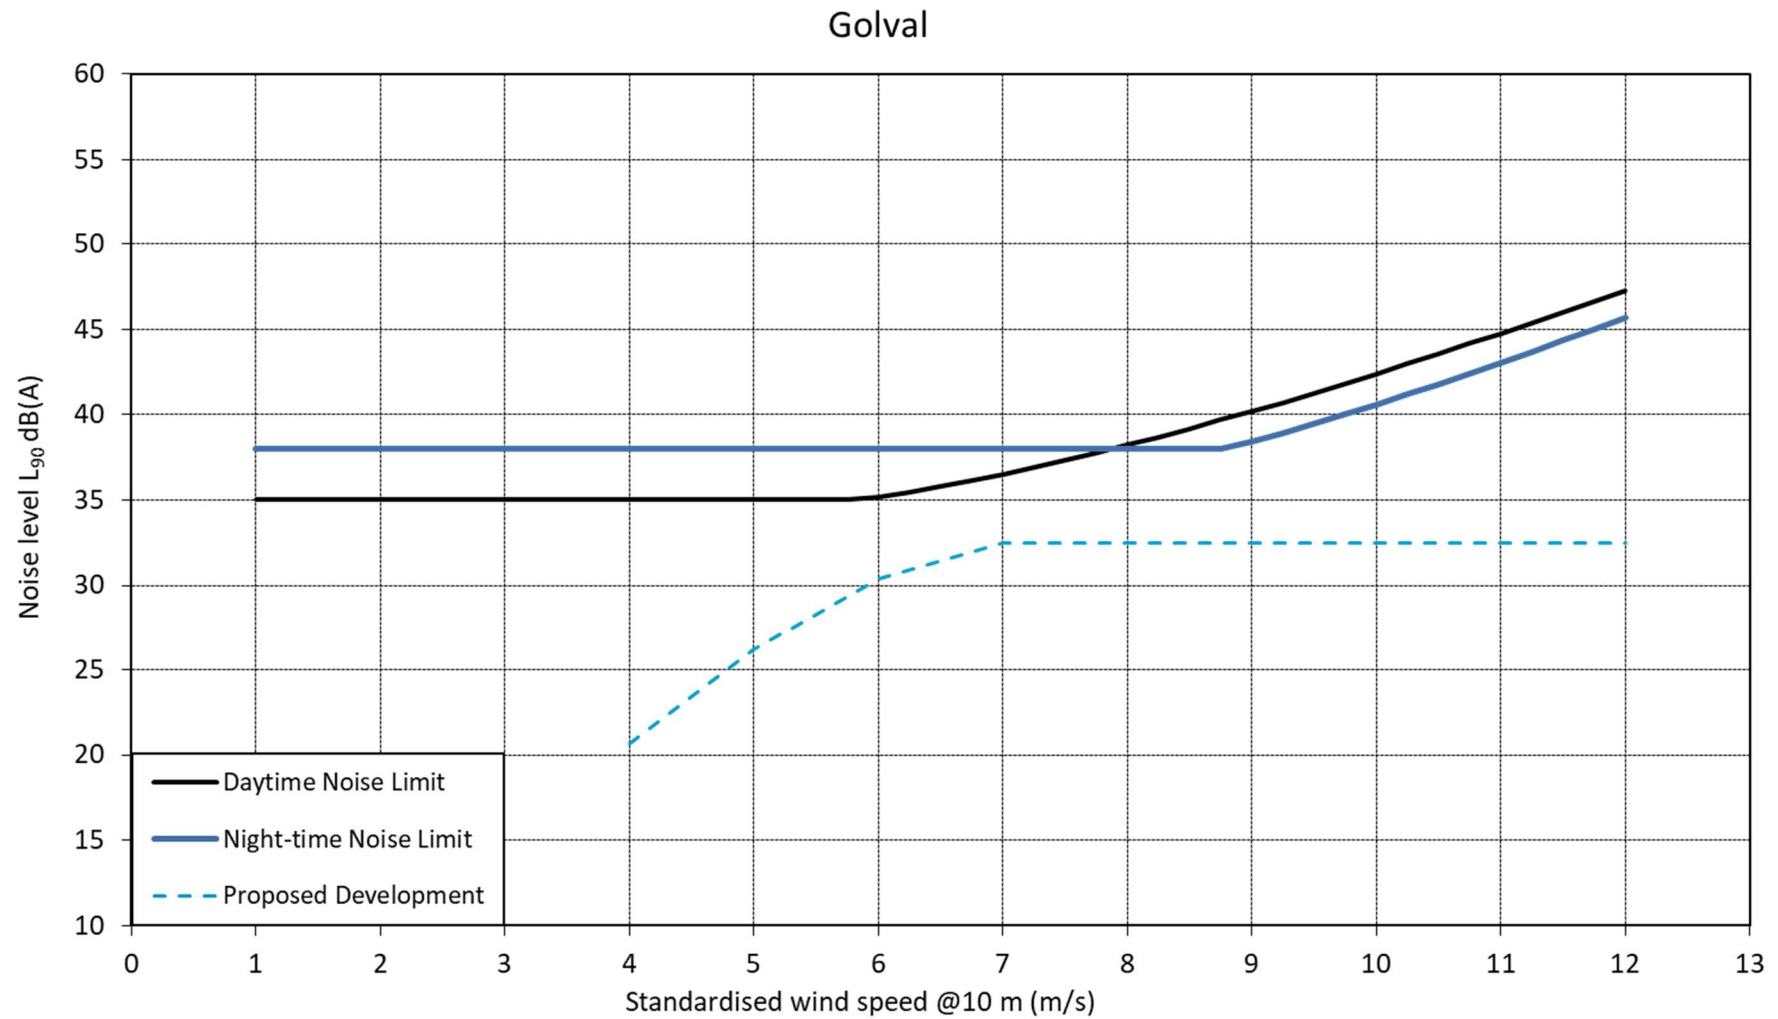
Graph 13-16: ETSU-R-97 Assessment Graph – NSR04 Golval

Background Noise Measured at: Tigh Na Breac

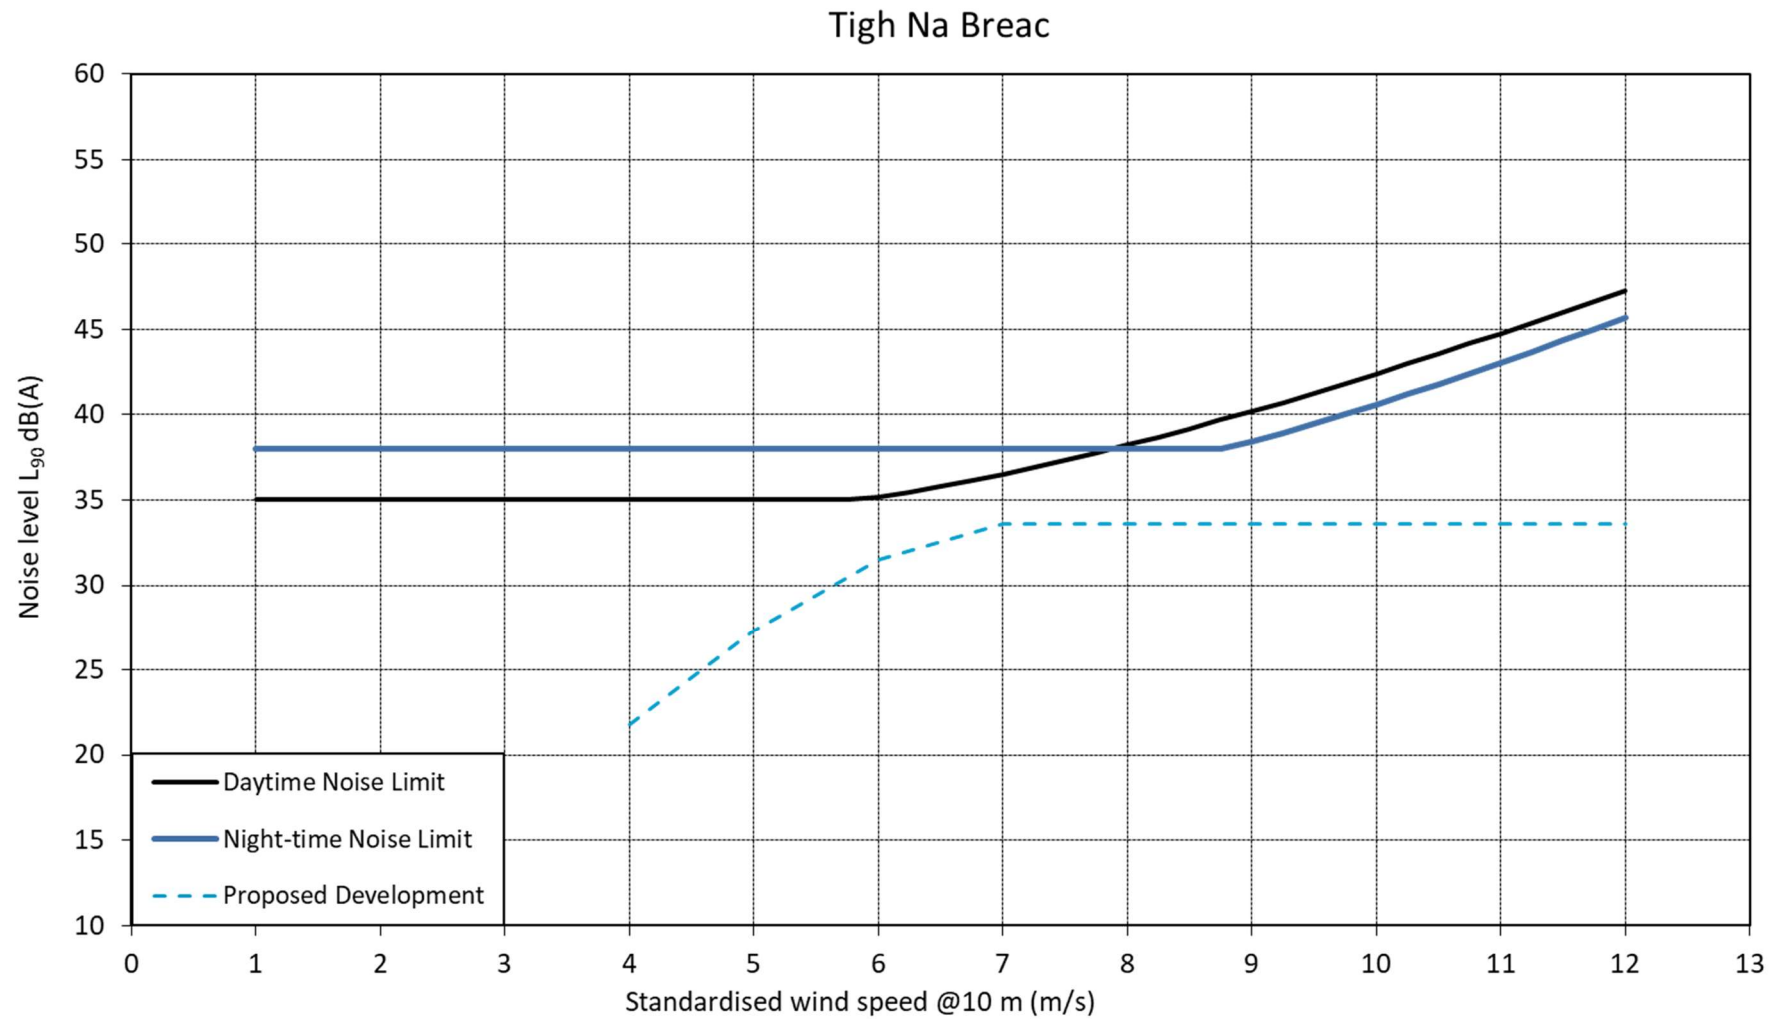
Graph 13-17: ETSU-R-97 Assessment Graph – NSR05 Tigh Na Breac

Background Noise Measured at: Tigh Na Breac

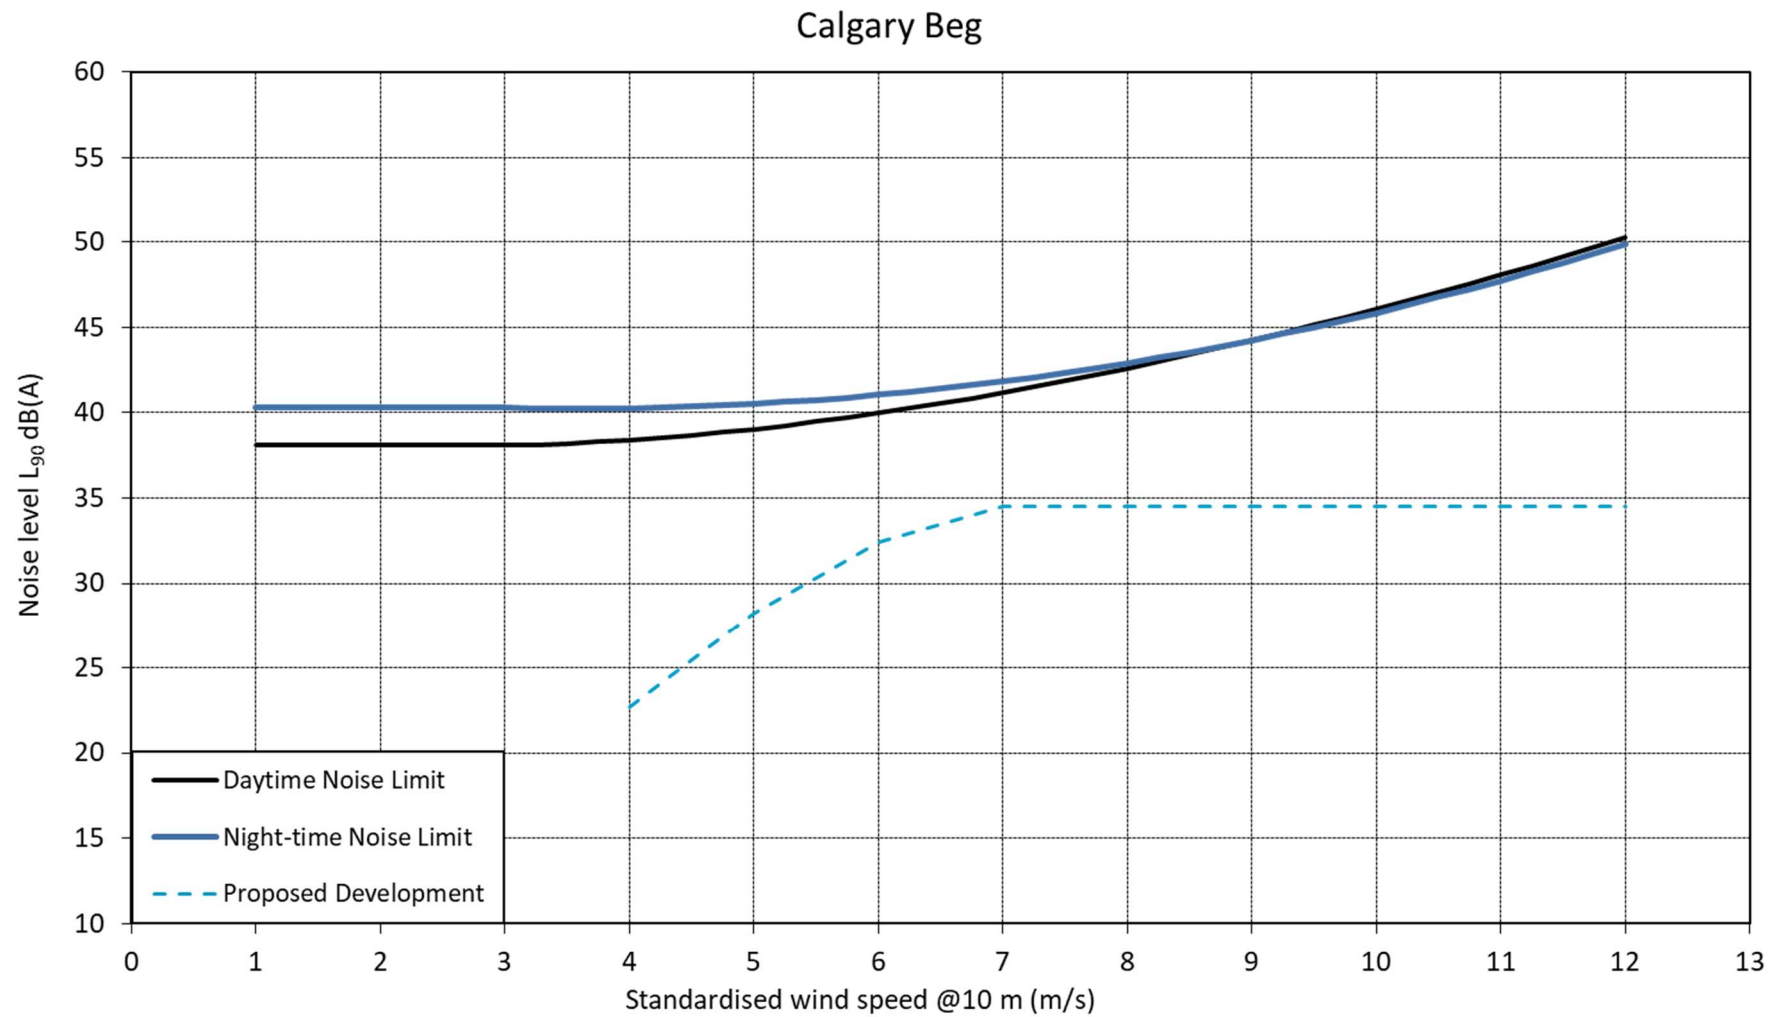
Graph 13-18: ETSU-R-97 Assessment Graph – NSR06 Calgary Beg

Background Noise Measured at: Calgary Beg

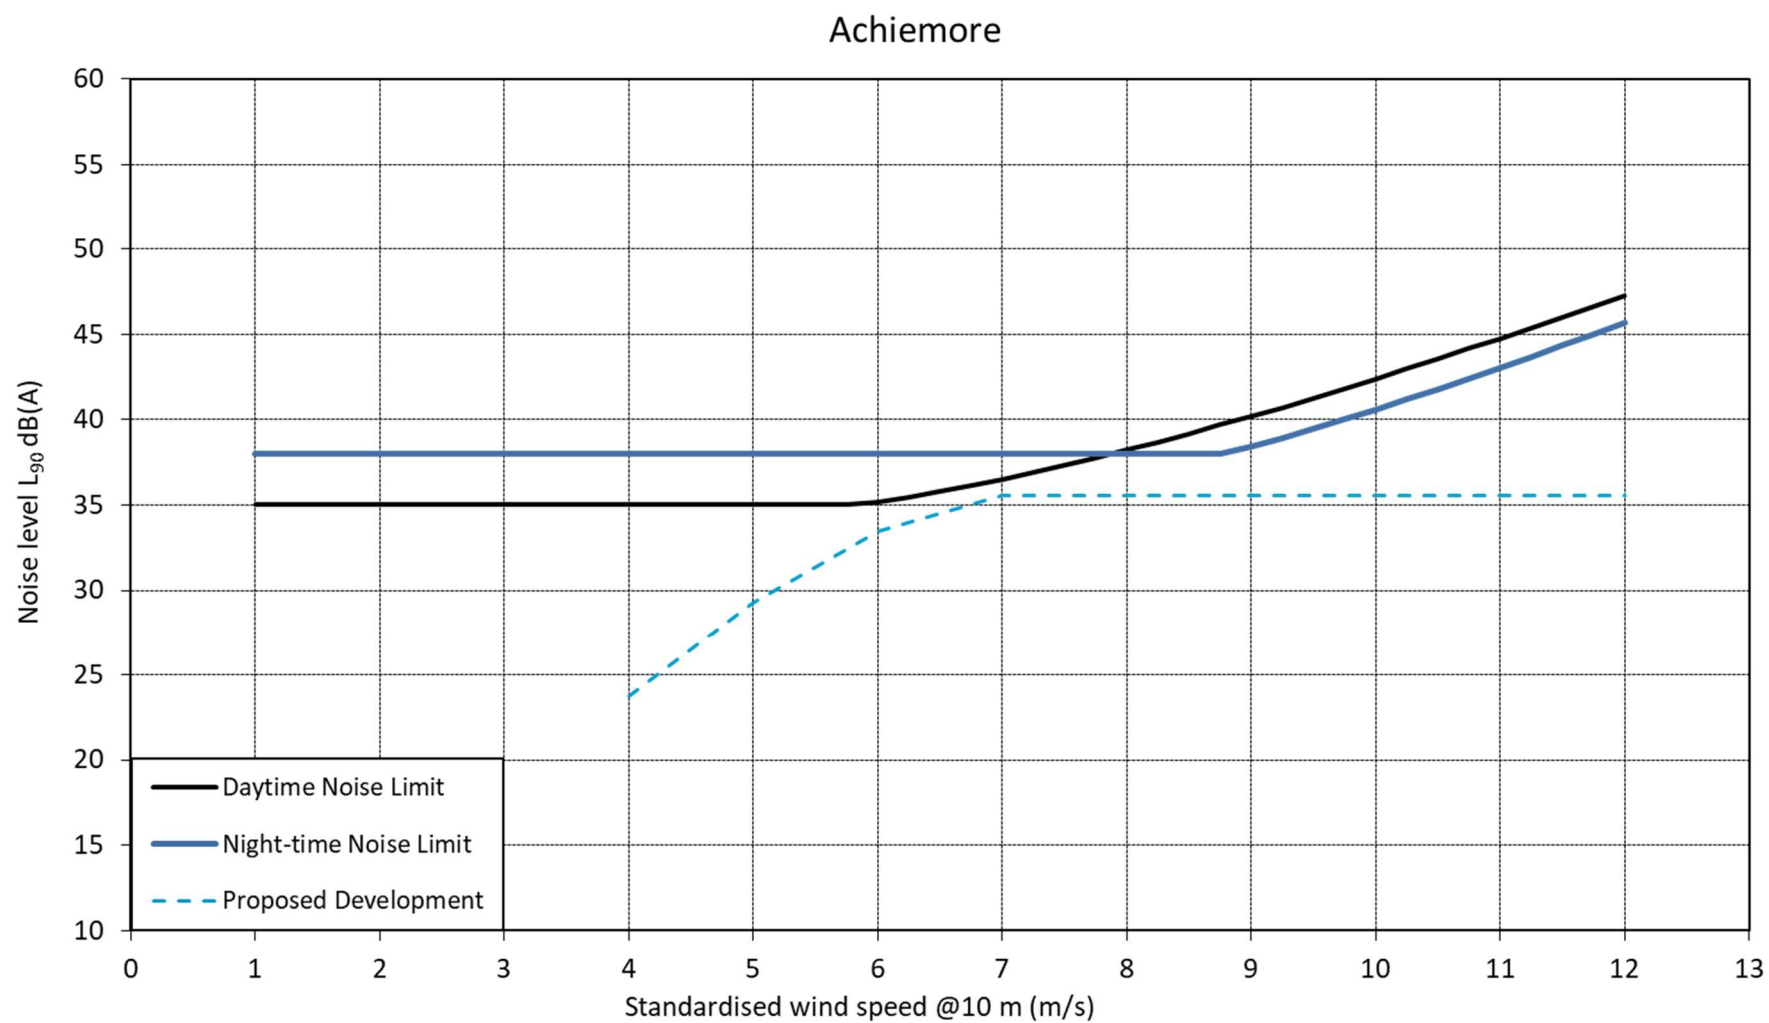
Graph 13-19: ETSU-R-97 Assessment Graph – NSR07 Achiemore

Background Noise Measured at: Tigh Na Breac

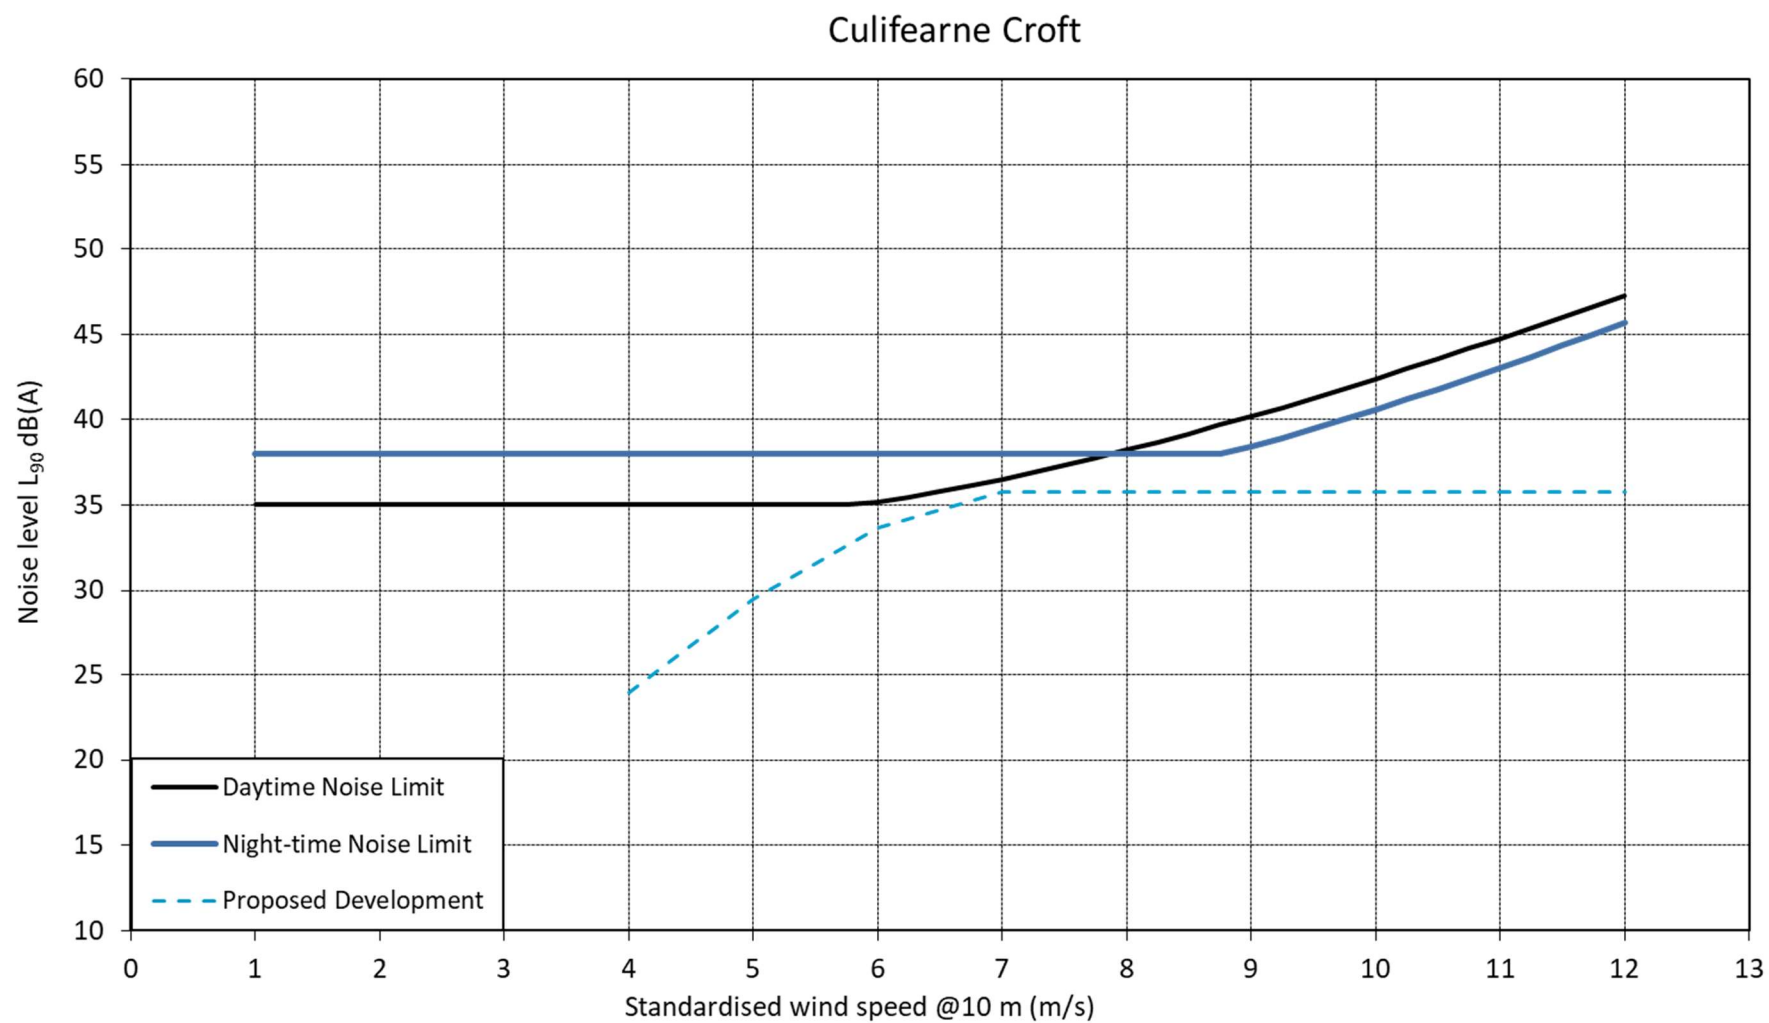
Graph 13-20: ETSU-R-97 Assessment Graph – NSR08 Culifearne Croft

Background Noise Measured at: Tigh Na Breac

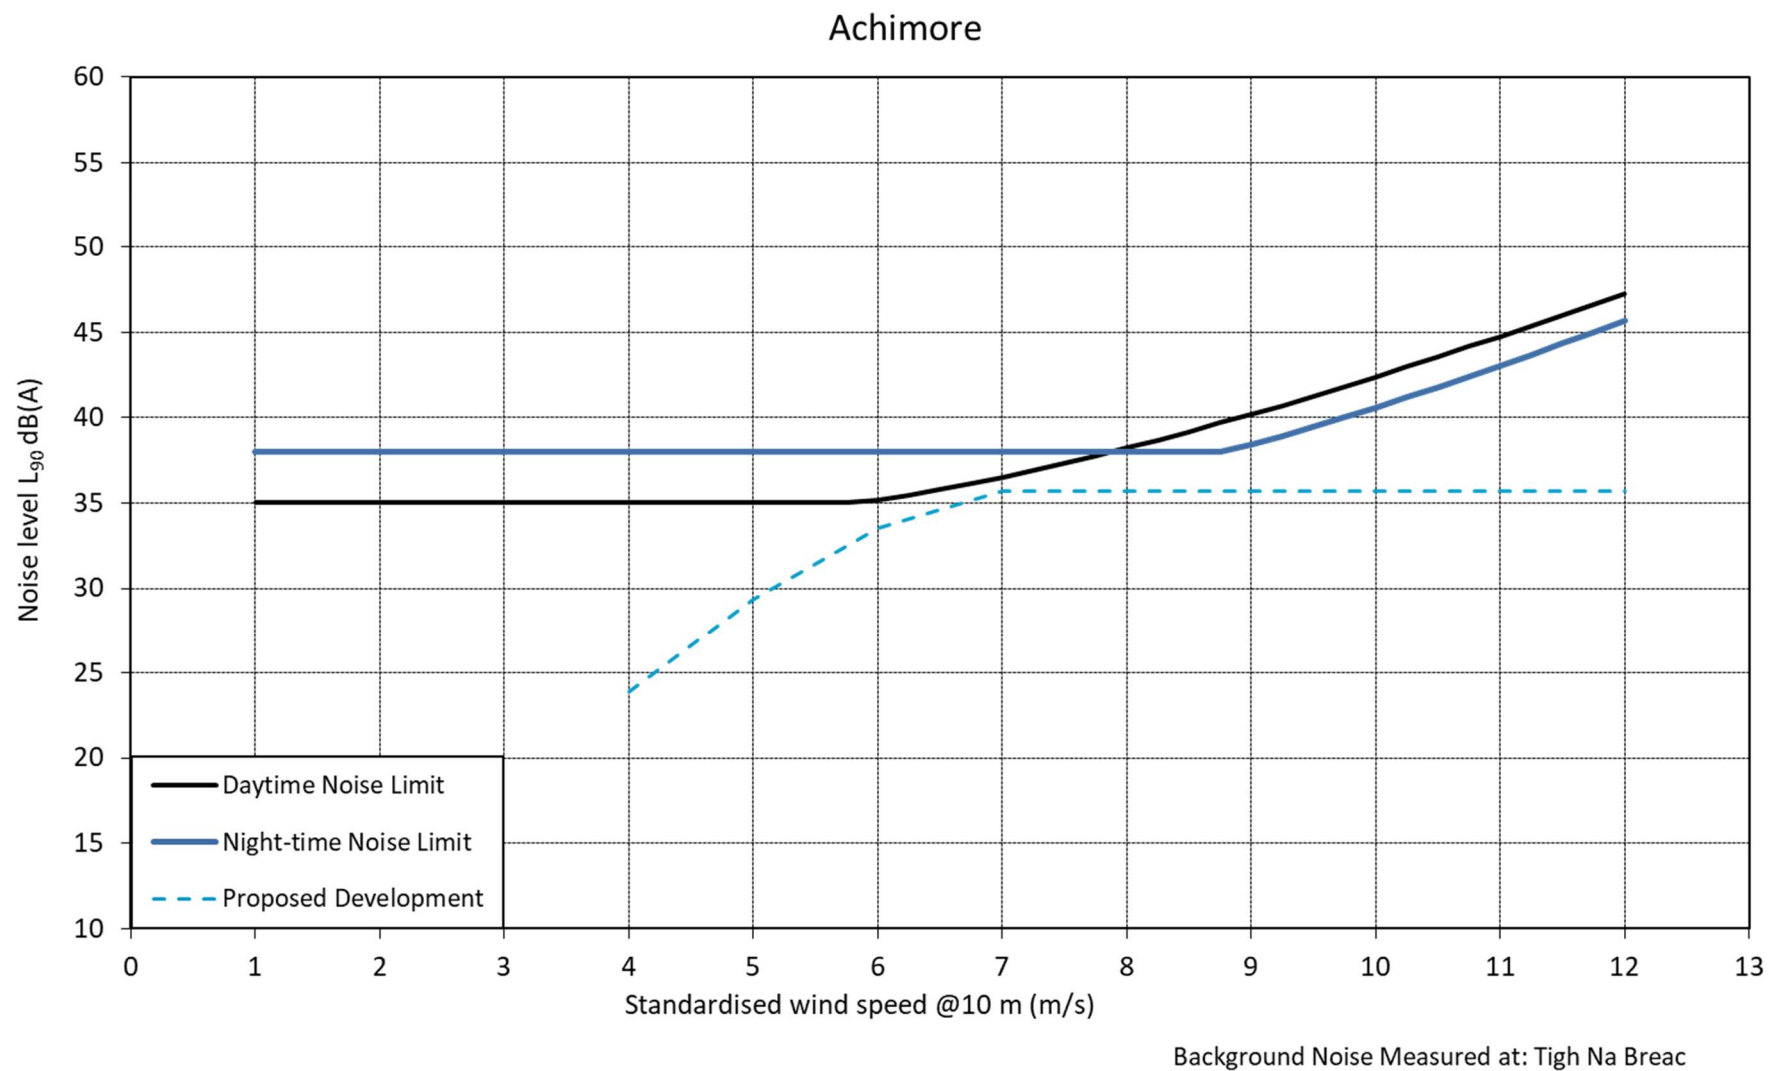
Graph 13-21: ETSU-R-97 Assessment Graph – NSR09 Achimore

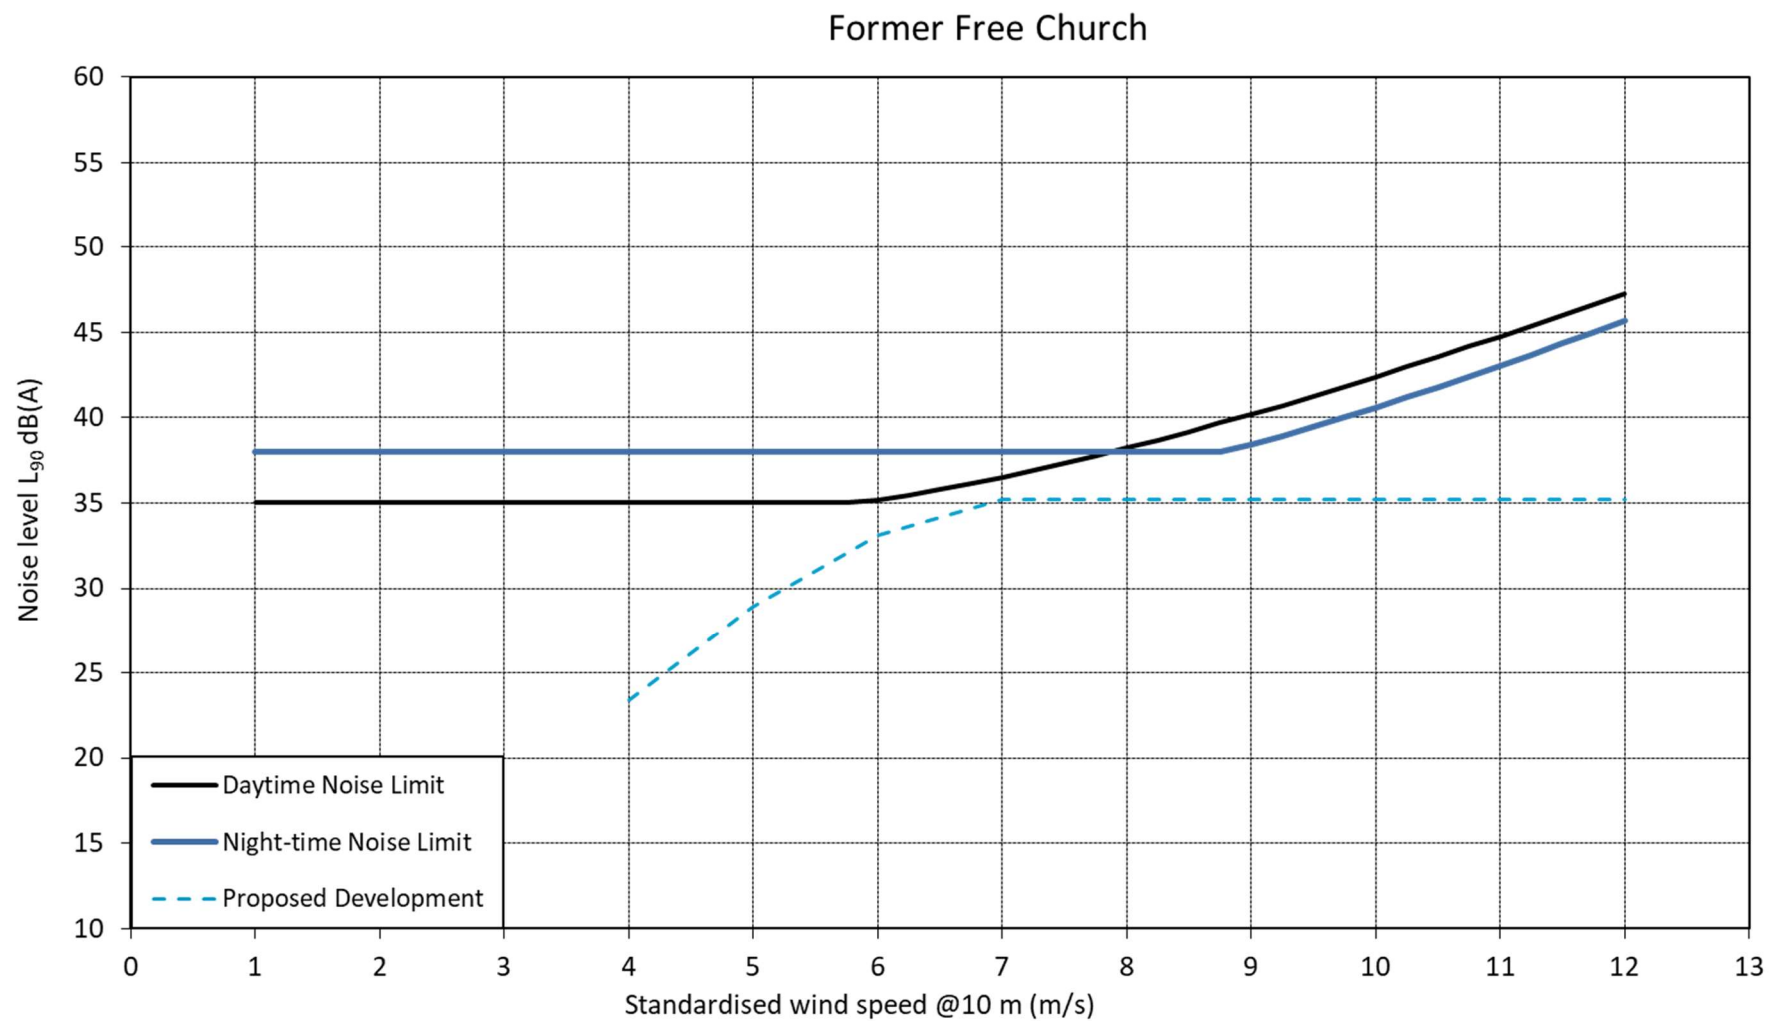
Graph 13-22: ETSU-R-97 Assessment Graph – NSR10 Former Free Church

Background Noise Measured at: Tigh Na Breac

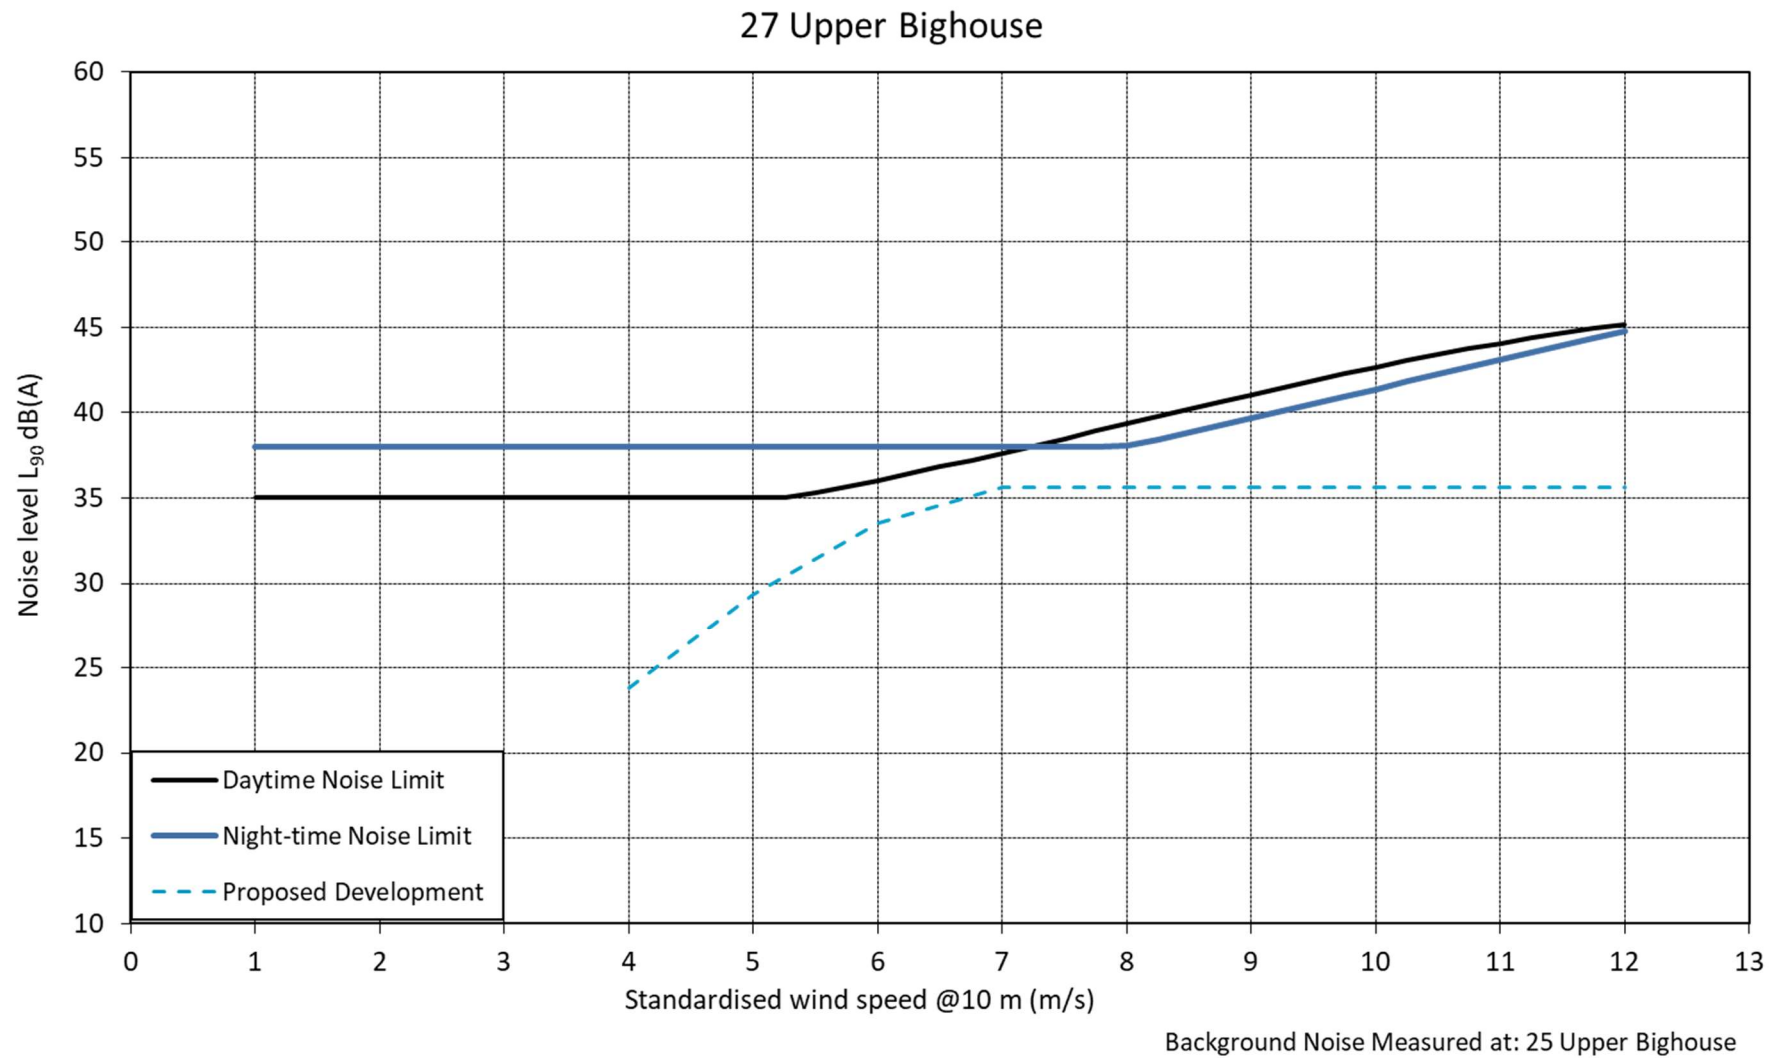
Graph 13-23: ETSU-R-97 Assessment Graph – NSR11 27 Upper Bighouse

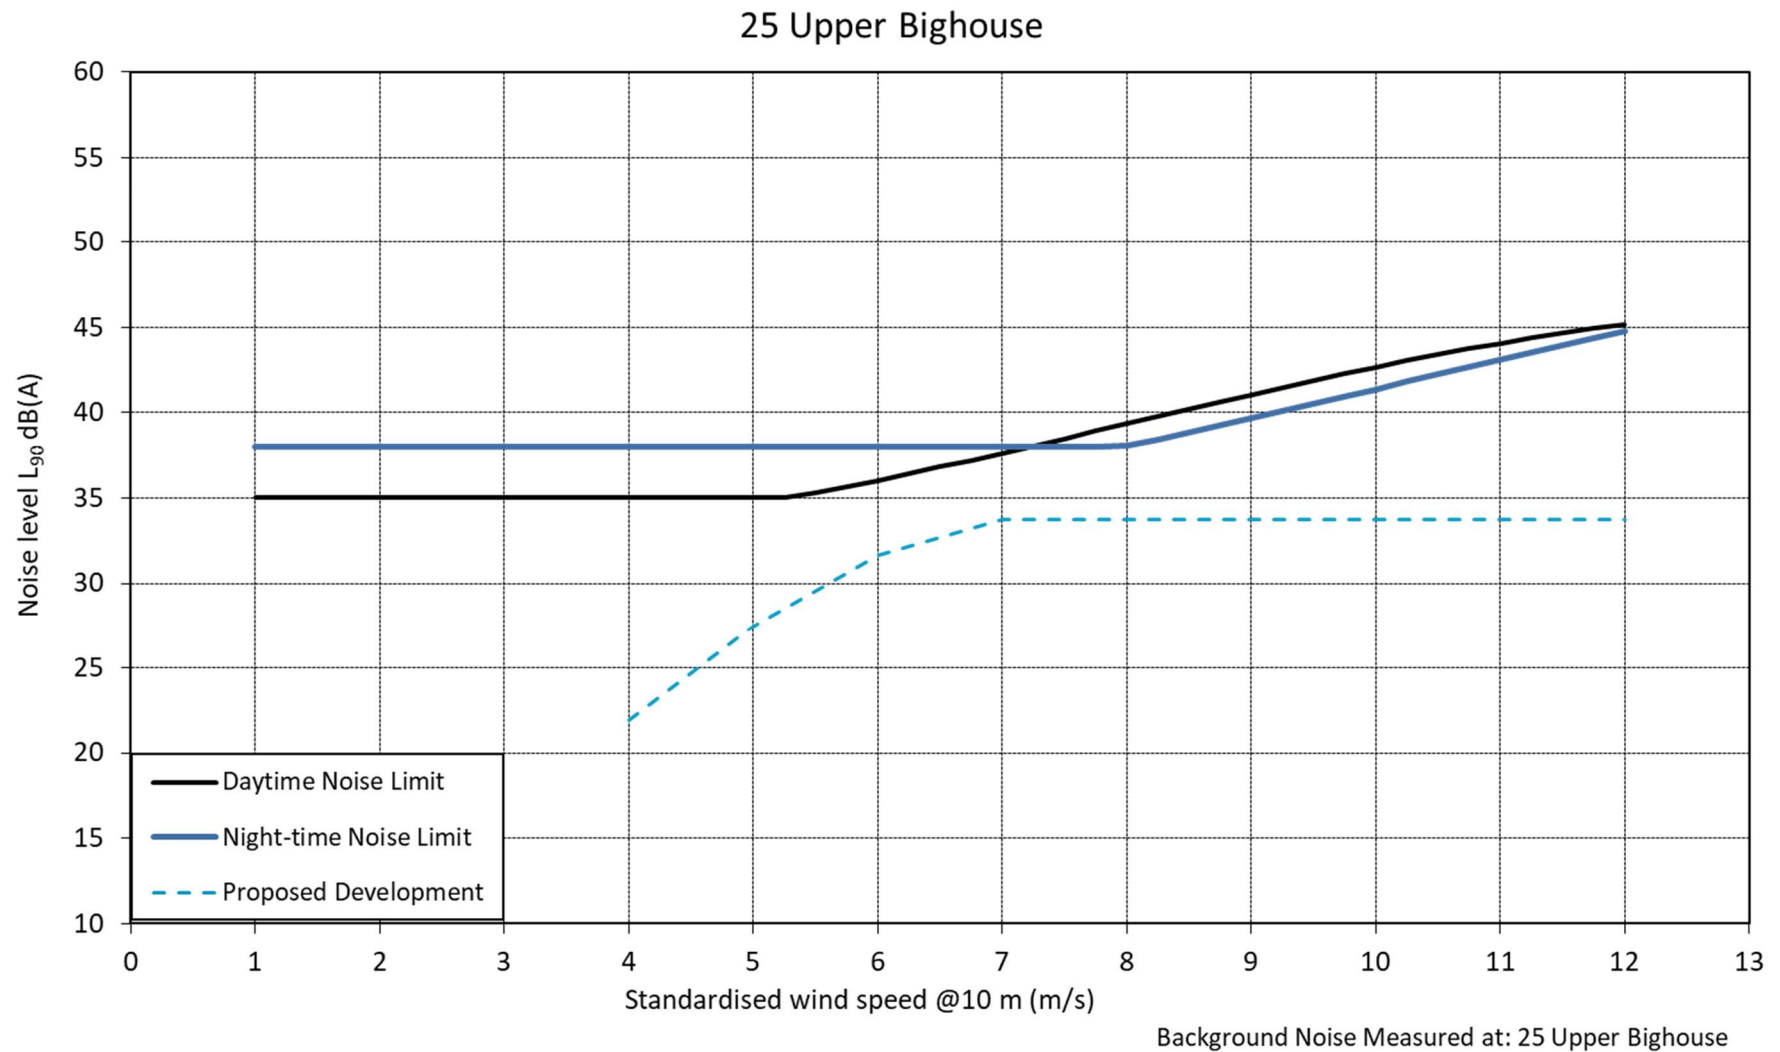
Graph 13-24: ETSU-R-97 Assessment Graph – NSR12 25 Upper Bighouse
