# TECHNICAL APPENDIX 13.6: ETSU-R-97 ASSESSMENT GRAPHS

**Kirkton Energy Park**  
Prepared for: Kirkton Wind Farm Ltd

SLR Ref: 428.11143.00001  
Version V1  
November 2022

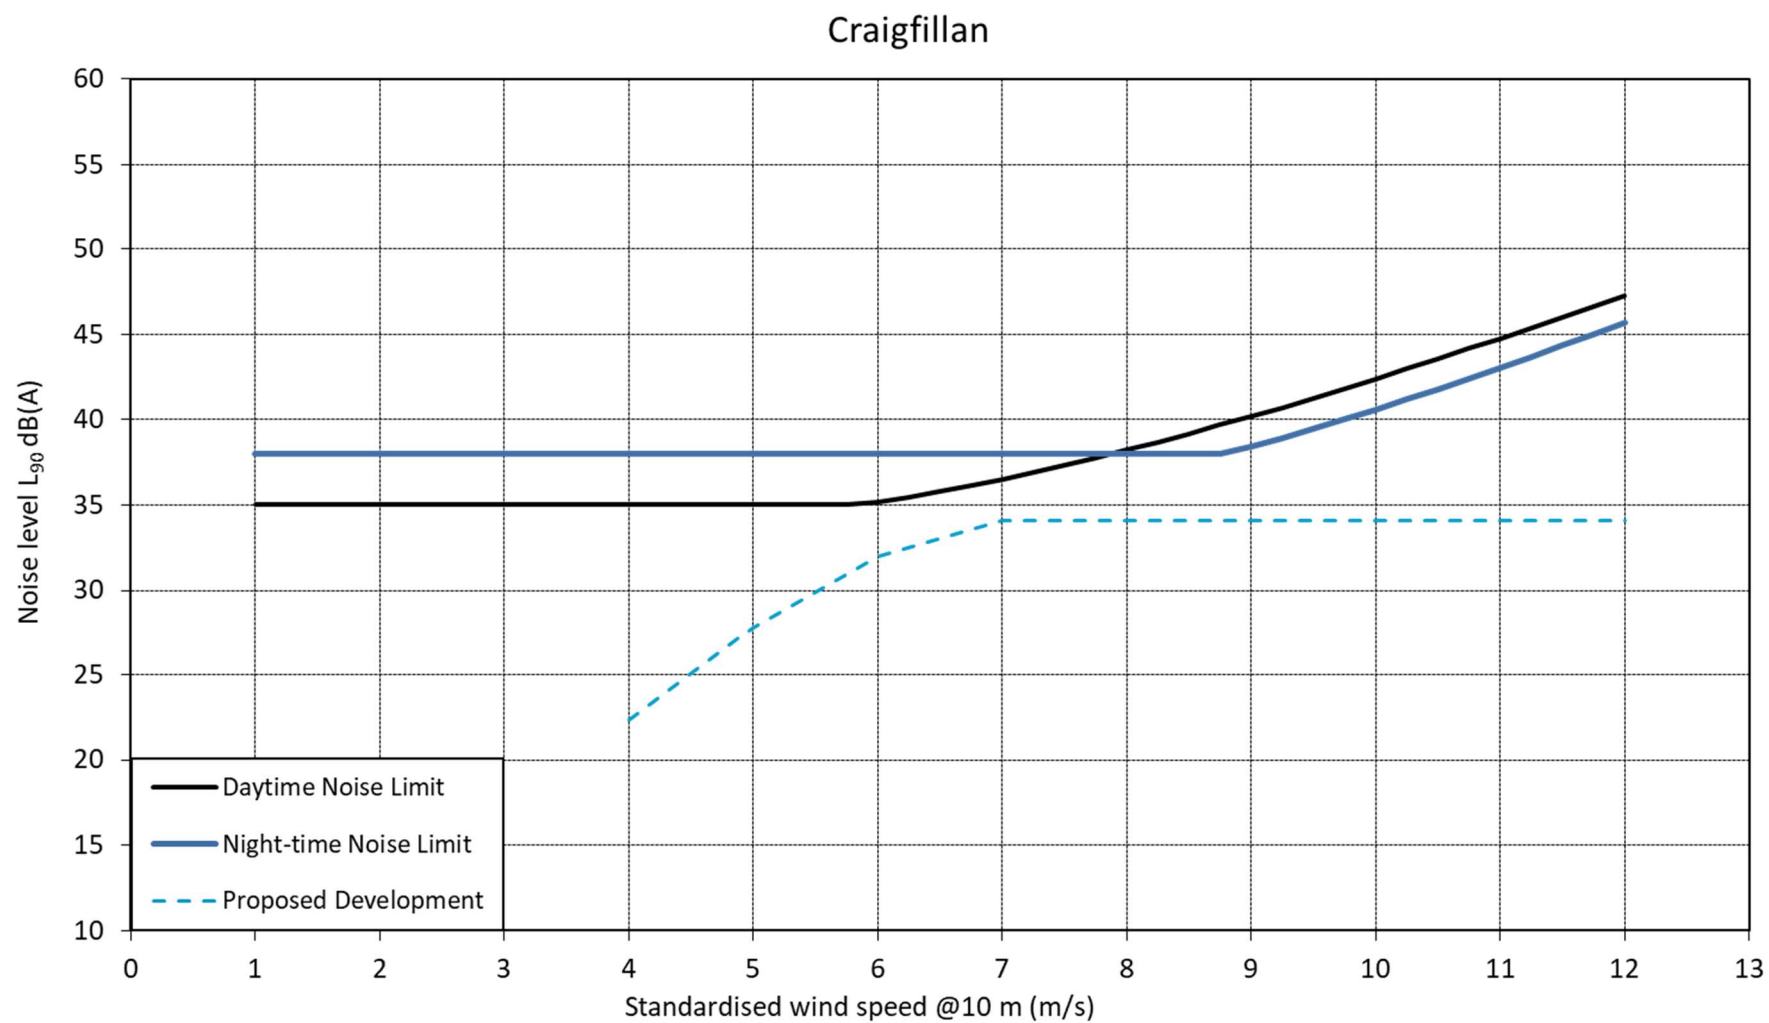
Graph 13-25: ETSU-R-97 Assessment Graph – NSR13 Craigfillan

Background Noise Measured at: Tigh Na Breac
