Technical Appendix 8.4

Kirkton Energy Park

Fish Habitat Survey

Kirkton Wind Farm Ltd.

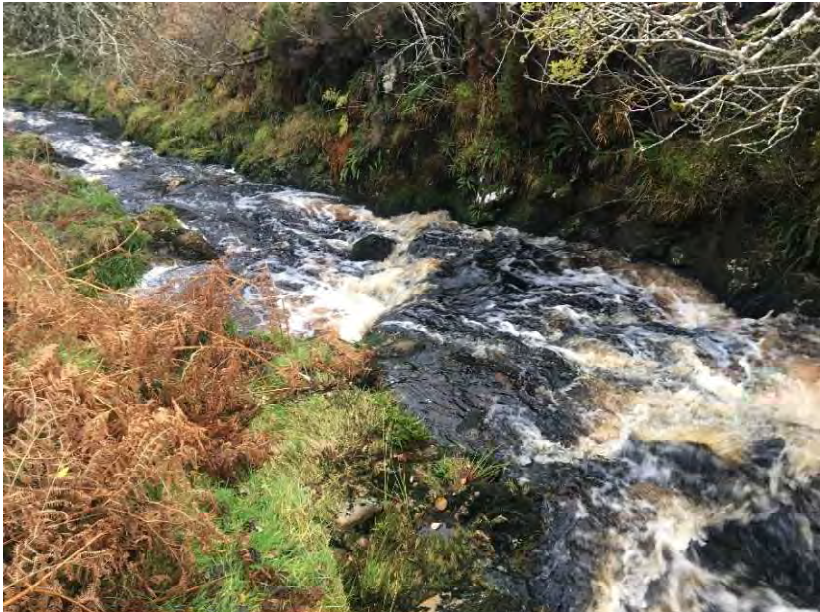
Target Note description	Photo
<p>TN1, Photo 1 - Allt na-h-Eaglaise - downstream extent - 2m wide / 50cm deep - good parr habitat.</p>

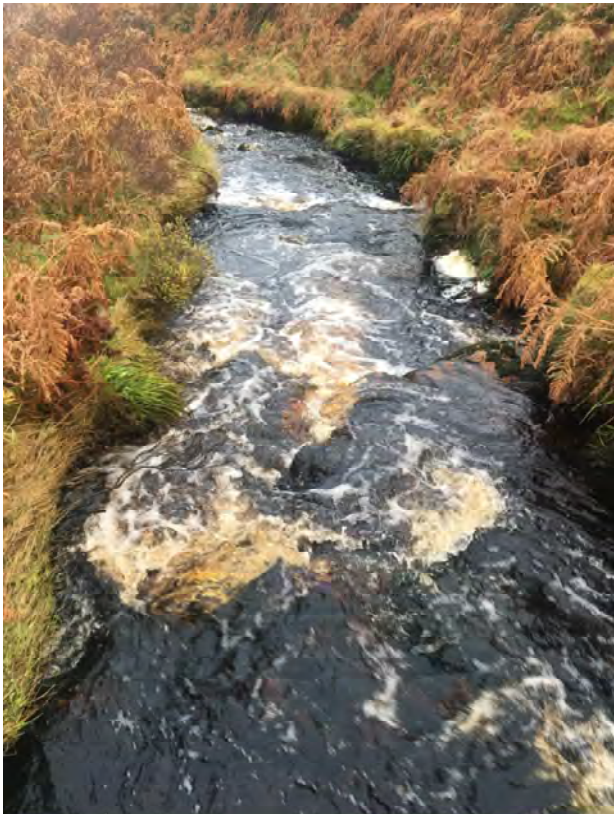
<p>TN2, Photo 2 - Allt na-h-Eaglaise - 2m wide / 50cm deep - good parr habitat.</p>

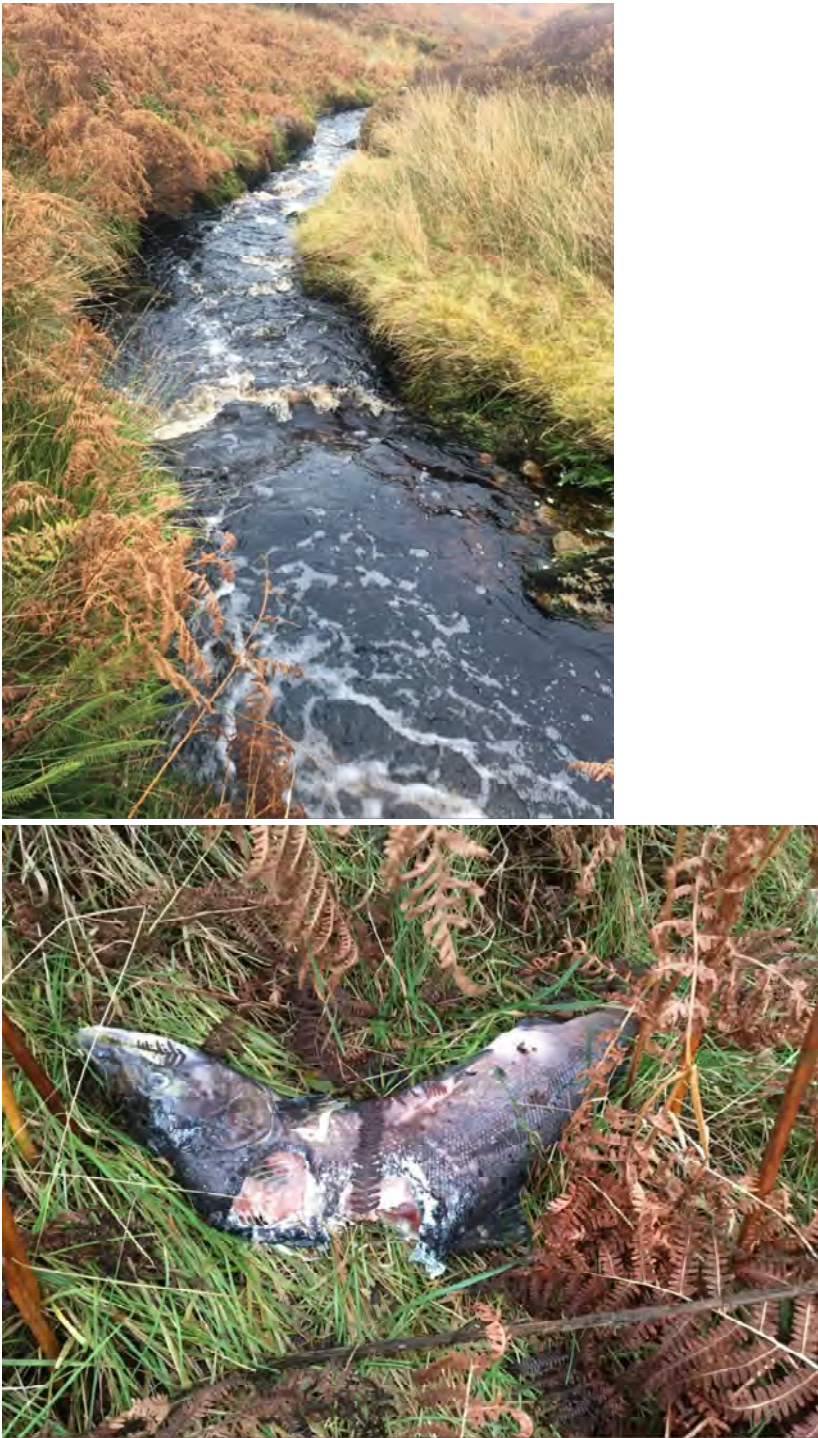
Target Note description	Photo
<p>TN3, Photo 3a - Allt na h-Eaglaise - downstream of bifurcation – 2m wide / 50cm deep – good parr habitat.</p> <p>Photo 3b (below) – predated kelt on river bank.</p>

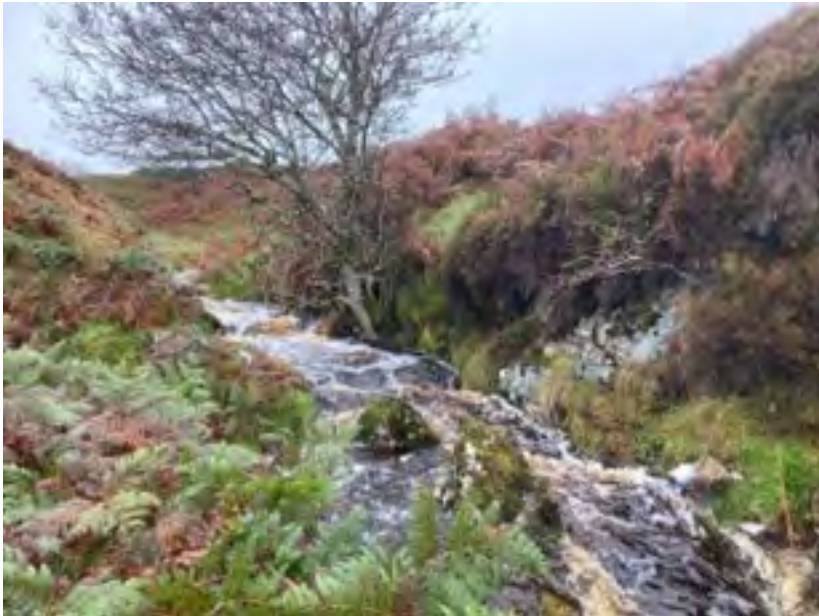
Target Note description	Photo
<p>TN8, Photo 8 - Allt na-h-Eaglaise – northern tributary - good fry / parr habitat – some bedrock intrusion.</p>

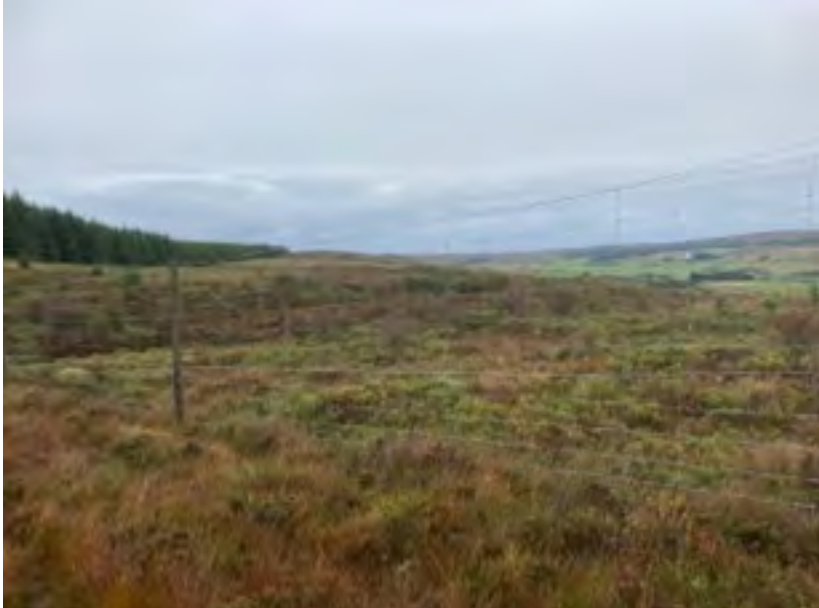
<p>TN9, Photo 9 - fenced area with native tree regeneration.</p>

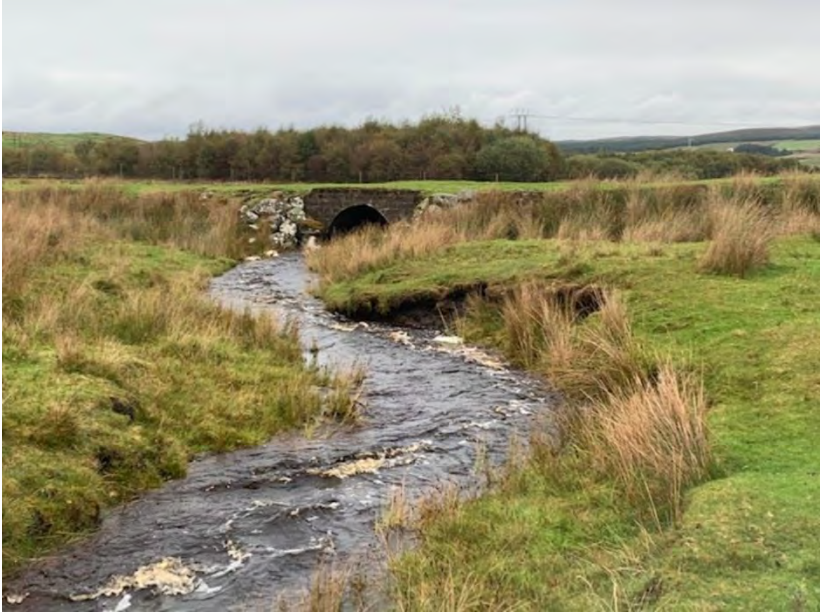
Target Note description	Photo
<p>TN10, Photo 10 - Allt na-h-Eaglaise – south tributary downstream extent - confluence with tributary good fry / parr habitat – track with bottomless culvert / bridge allowing good access for fish.</p>

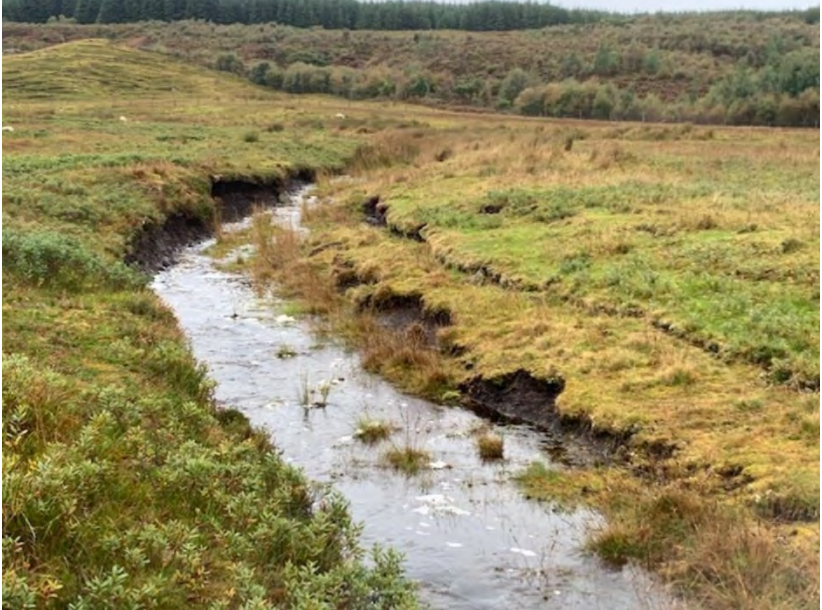
<p>TN11, Photo 11 - Allt na-h-Eaglaise – southern tributary - good fry / parr habitat.</p>

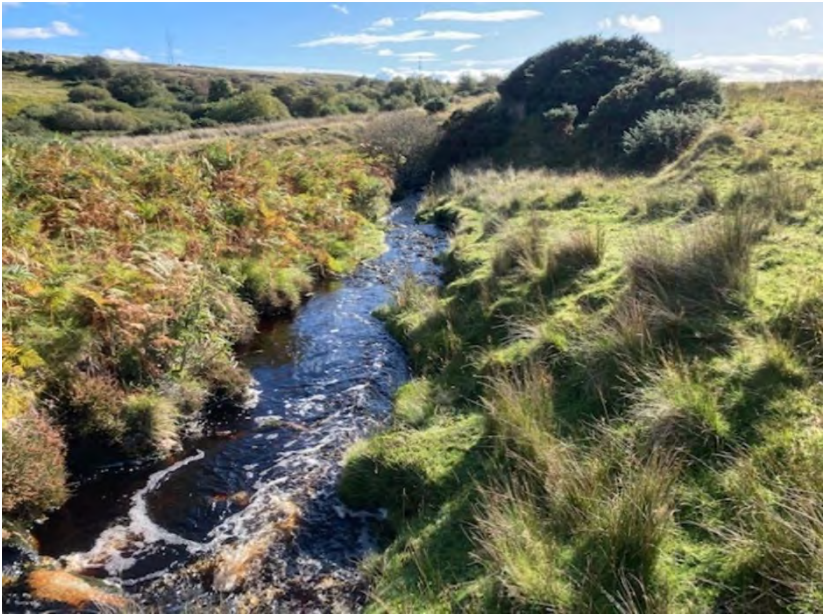
Target Note description	Photo
<p>TN33, Photo 33 - Allt an Tigh-Choinneimh – lower section, good parr habitat.</p>

ALLT AN TIGH-CHOINNEIMH						
33	Photo 33	Parr	Allt an Tigh-Choinneimh – lower section, good parr habitat.	No	Passable	High
34	Photo 34	Fry	Run – lower section – good potential for fry.	No	Passable	High
35	Photo 35	Fry	Run – lower section – good potential for fry.	No	Passable	High
36	Photo 36	Parr	Run – mid section – good parr habitat.	No	Passable	High
37	Photo 37	Fry / Parr	Run – mid section d/s gorge, good potential for fry / parr.	No	Passable	High
38	Photo 38	Flow constriction	Upper section – constricted channel in bedrock dominated gorge – limited fish potential.	No	Passable	Low
39	Photo 39	Flow constriction	Run – upper section – constricted channel in bedrock dominated gorge – limited fish potential.	No	Passable	Low
40	Photo 40	Flow constriction	Run – upper section – constricted channel in bedrock dominated gorge – limited fish potential.	No	Passable	Low
41	Photo 41	Fry	Run – upper section – bedrock dominated channel upstream of gorge – limited fish habitat.	No	Passable	Low
